# Operational Warning Signs, Root Cause Evaluation & Restoration Strategy for a Large WTE Steam Turbine

*Bill Embree  
Josh Miller, PE*

July 20, 2026

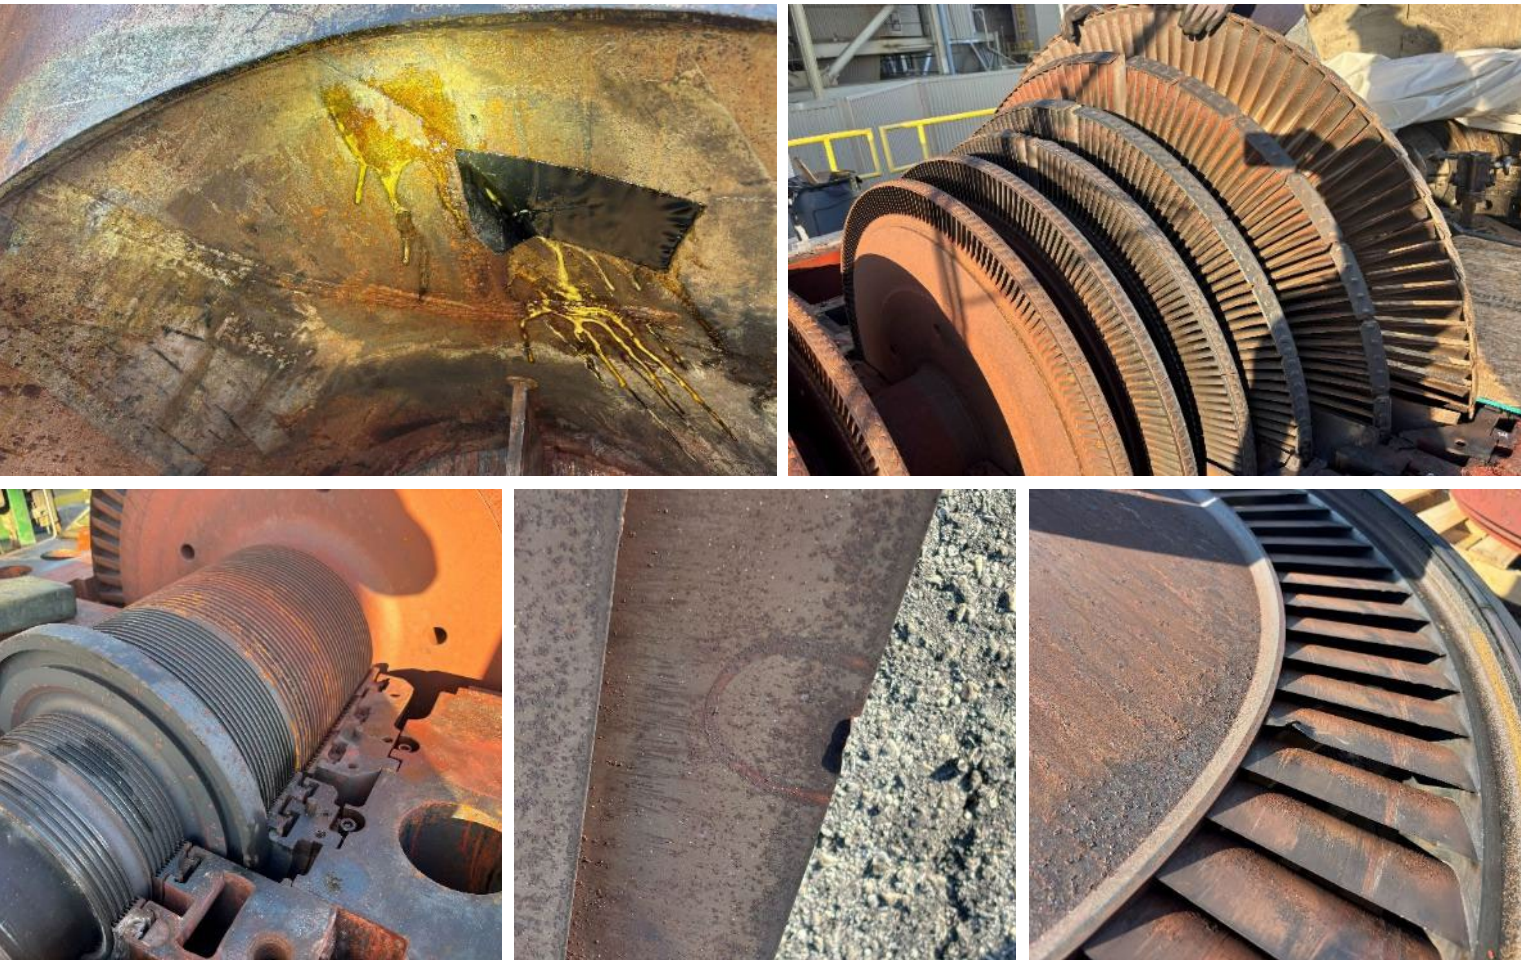
- › Stage 11 blade liberation (2 blades)
- › DOD on stage 12 diaphragms
- › HP gland seal packing failure
- › LP hood crack
- › Pitting/corrosion on stages 2-8
- › Minimal casing erosion

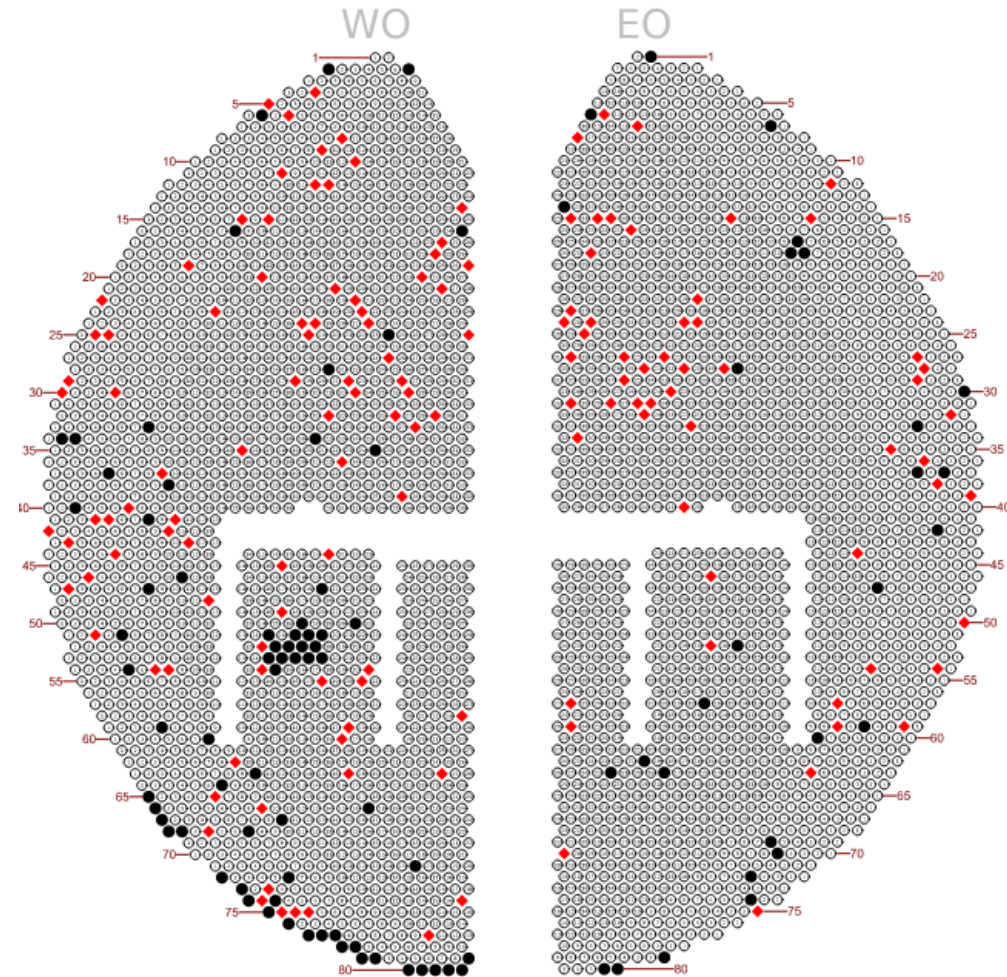
- › Total tubes: 3750
- › Material: Adm. Brass
- › Tubes plugged: 241, 6.4%
- › Tubes remaining with >70% wall thickness loss: 335
- › Recommended max tubes plugged: 10%, 375
- › Near EOL, new tubes/tube sheet required soon

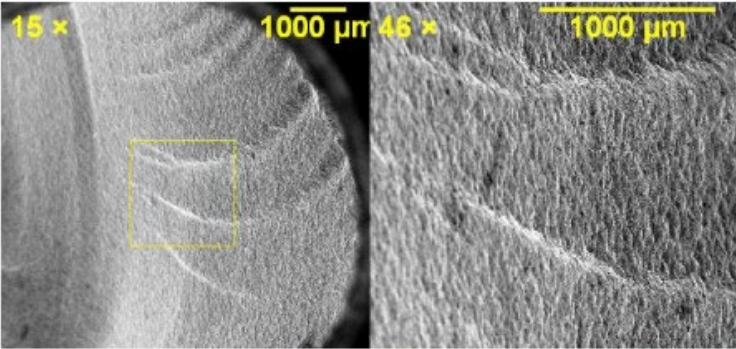
- › Primary failure initiated in Blades 188 and 208 due to high-cycle fatigue (HCF).
- › Secondary impact damage identified on Blades 1-4 and 60.
- › No evidence of stress-corrosion cracking (SCC) or corrosion fatigue.
- › Blade vibration and dovetail fretting indicate vibration-driven fatigue mechanism.
- › Deposits and steam contamination likely increased blade imbalance and vibrational stress.
- › Corrosion and pitting contributed, but not primary failure cause.
- › Deposits likely reduced efficiency and increased vibration through flow disruption.

**Figure 28.** Beach marks, Blade #188, SEM image

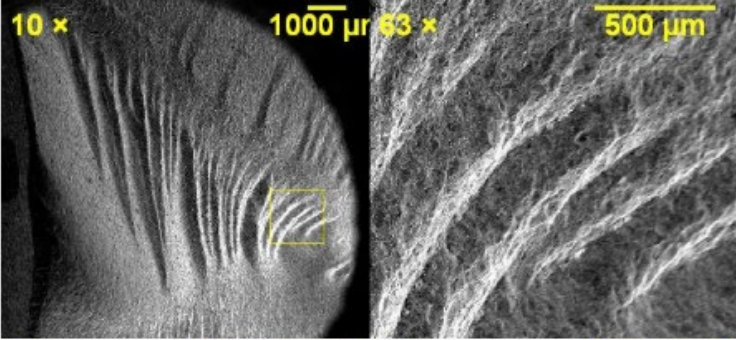
**Figure 29.** Beach marks, Blade #208, SEM image

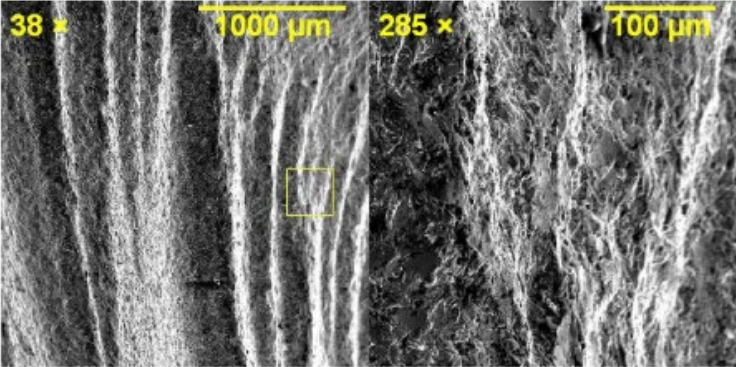
**Figure 30.** Beach marks, Blade #208, SEM image

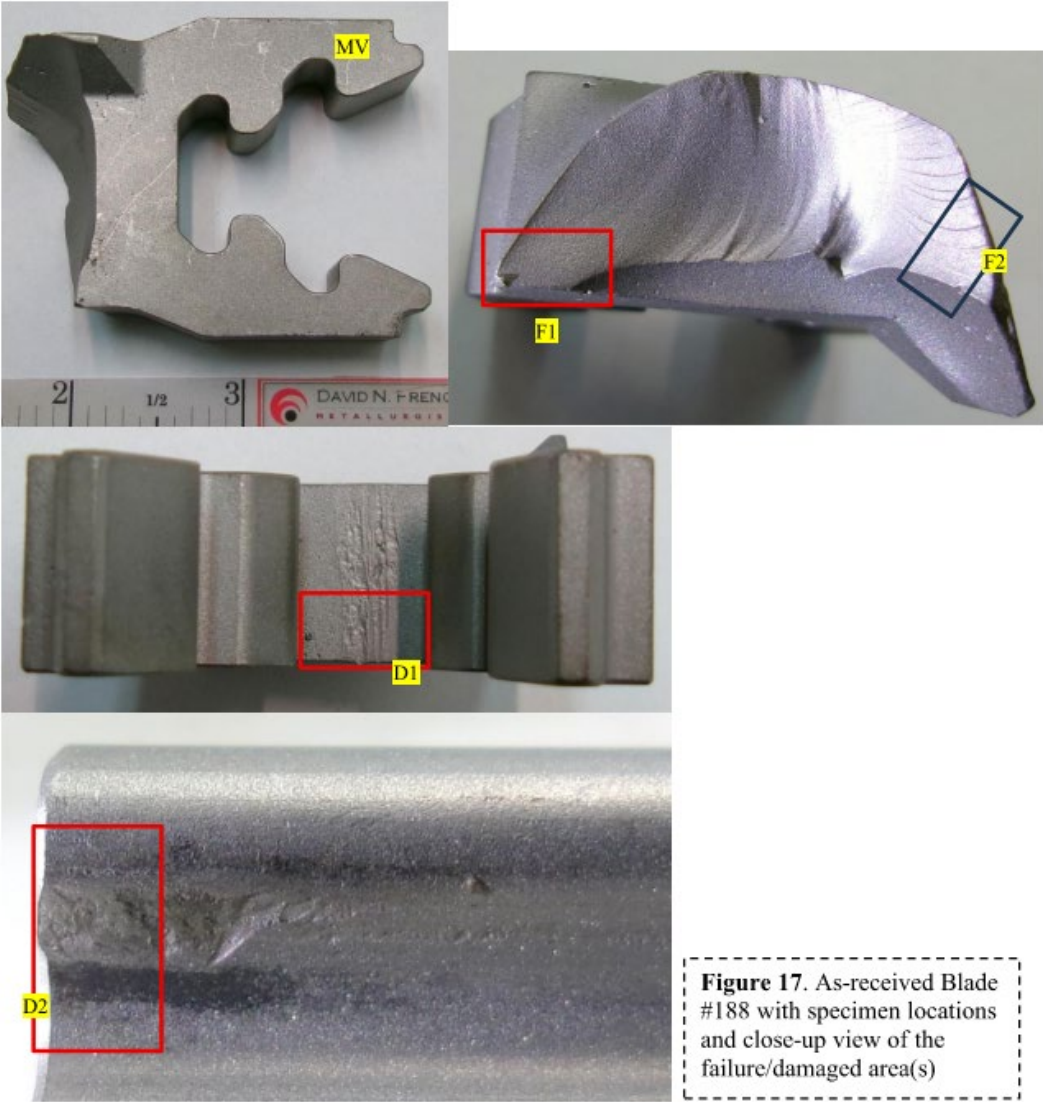
**Figure 17.** As-received Blade #188 with specimen locations and close-up view of the failure/damaged area(s)

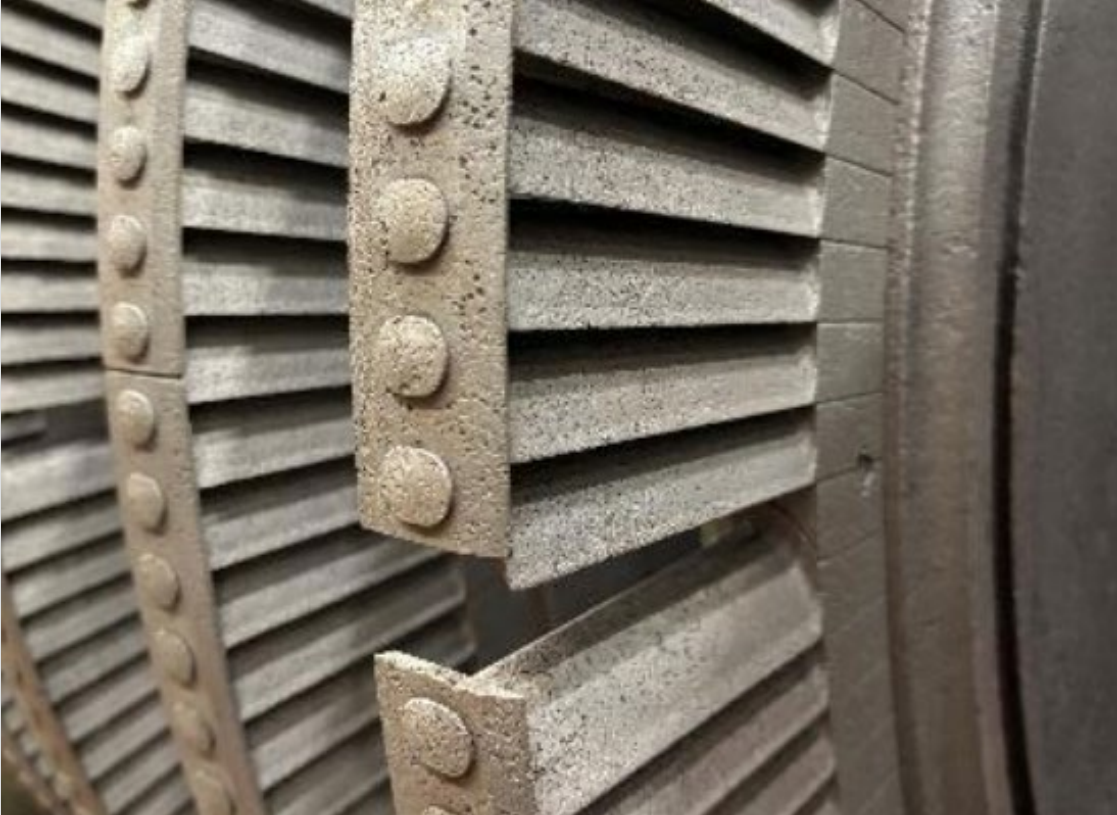
- › Widespread degradation - severe pitting, erosion, rubbing, localized FOD. Most significant damage in Stages 2-8.
- › Admission side erosion on stages 5-8, indicating prolonged exposure to contaminated or erosive steam conditions
- › Stages 3 and 4 exhibited FOD in addition to severe pitting
- › Several stages exhibited opened notches, lack of tenon engagement and rubbing conditions
- › Rotor journals and coupling dimensions were generally within acceptable limits; no cracking indications

**Stage 8 Buckets/Tenons** – Heavy Pitting/Erosion

Replace Stages 2-8 now, future replacement of Stages 9-10, and correction of several mechanical integrity issues

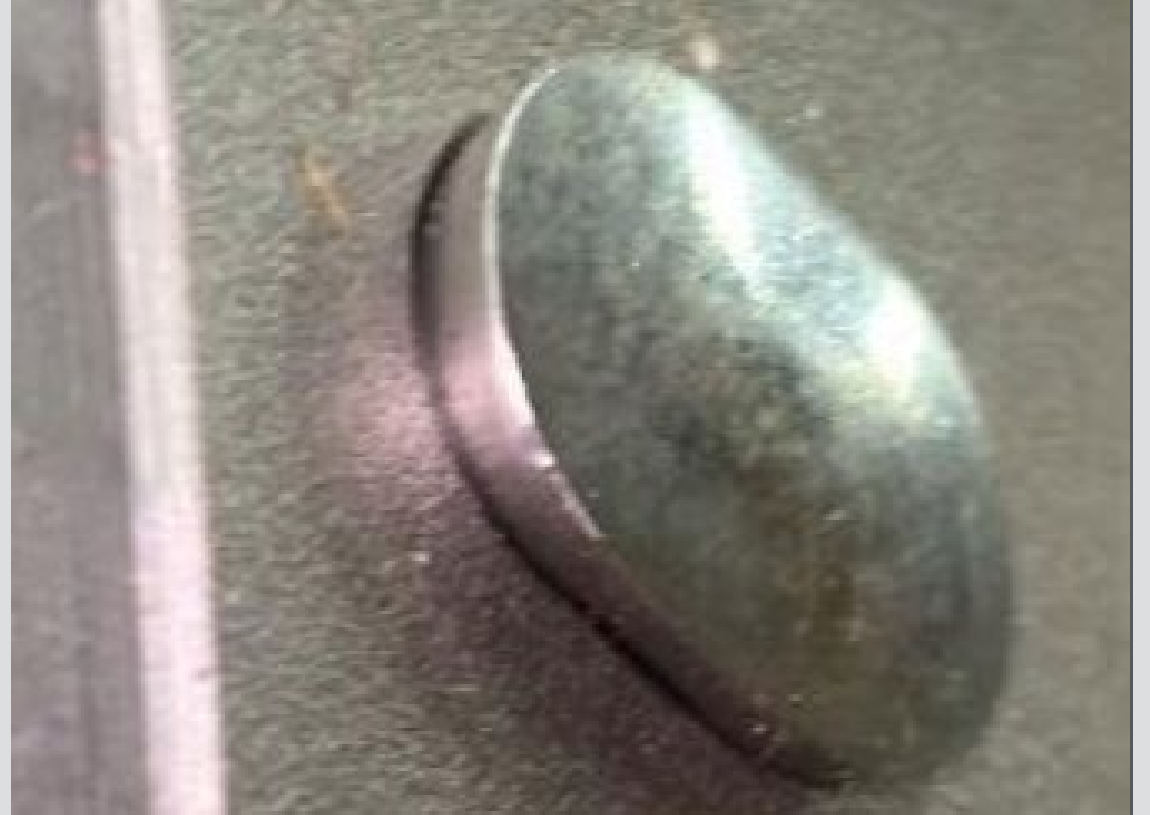
**Stage 11 (New) Tenons** – High, Chamfer Visible;  
several blade edges dented

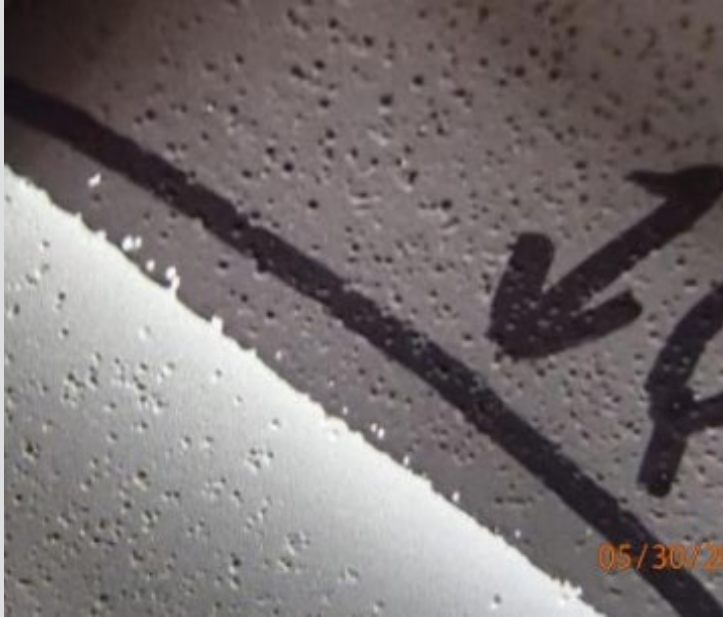
**Stage 10 LH Pinhole in Partition  
Trailing Edge**

Extensive diaphragm refurbishment and steam-seal restoration to return the turbine to reliable operation and designed performance.

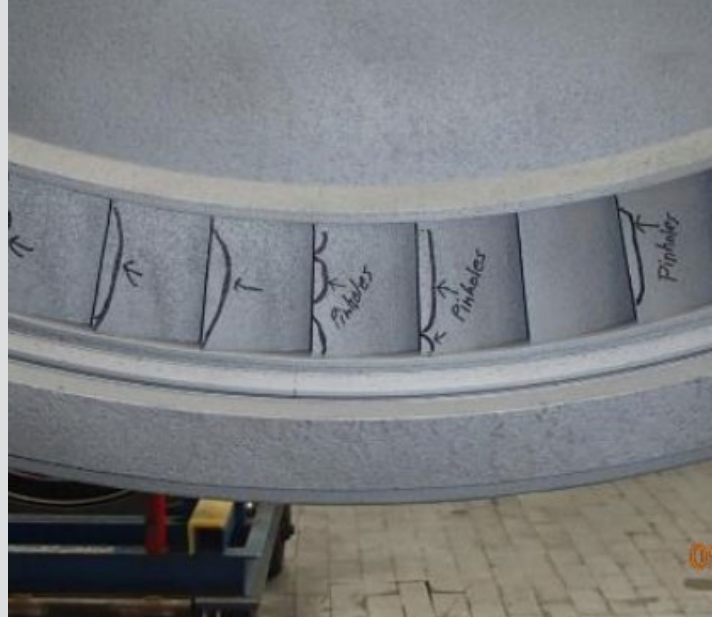
**Stage 9 LH Pinholes in Partitions**

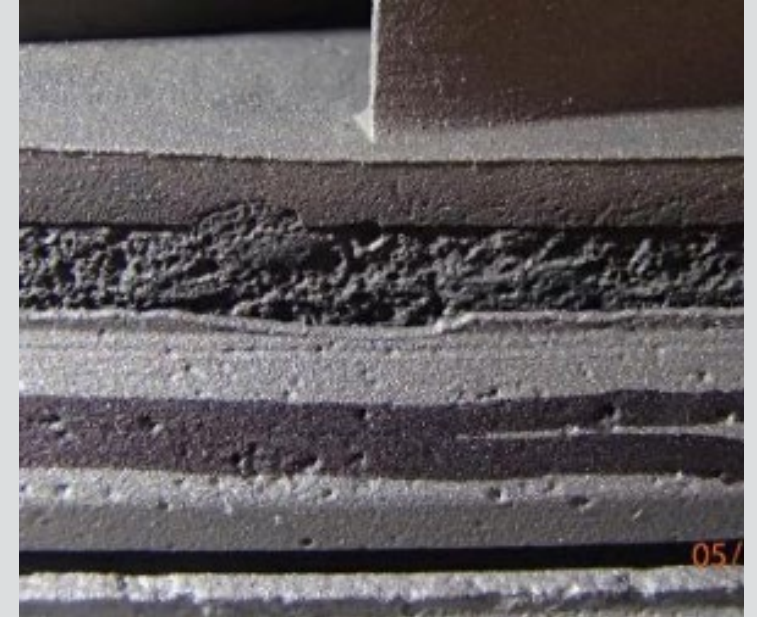
**Stage 4 UH Erosion and Rub on  
Spill Strips**
