Creating Durable Concrete Floors

Bob Swan
HD Concrete Floors

Improving Concrete Tipping Floors

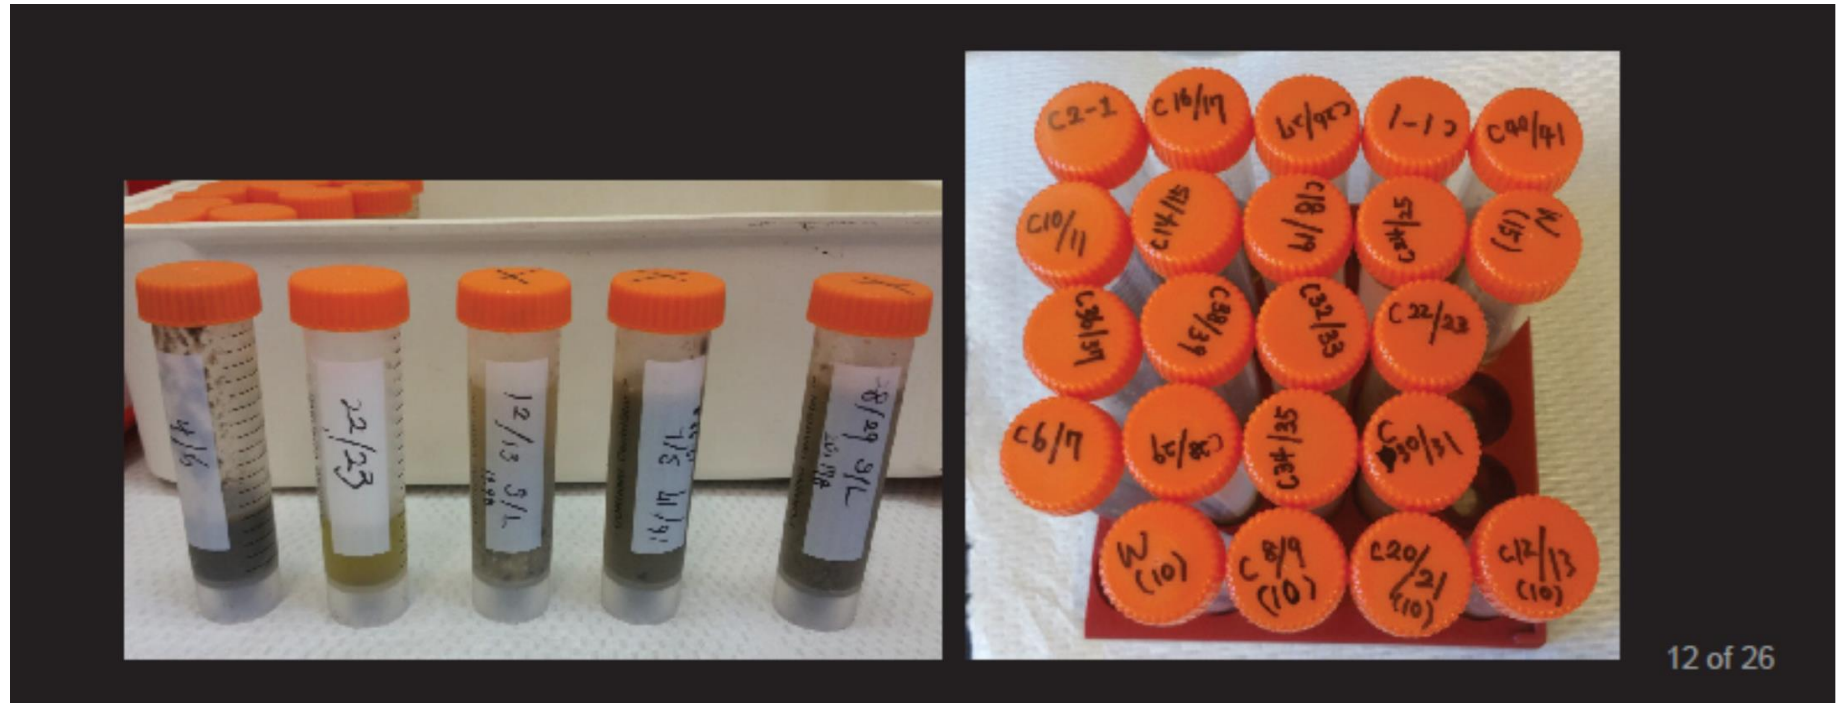
A number sample were collected from landfills, transfer stations and anaerobic digesters.

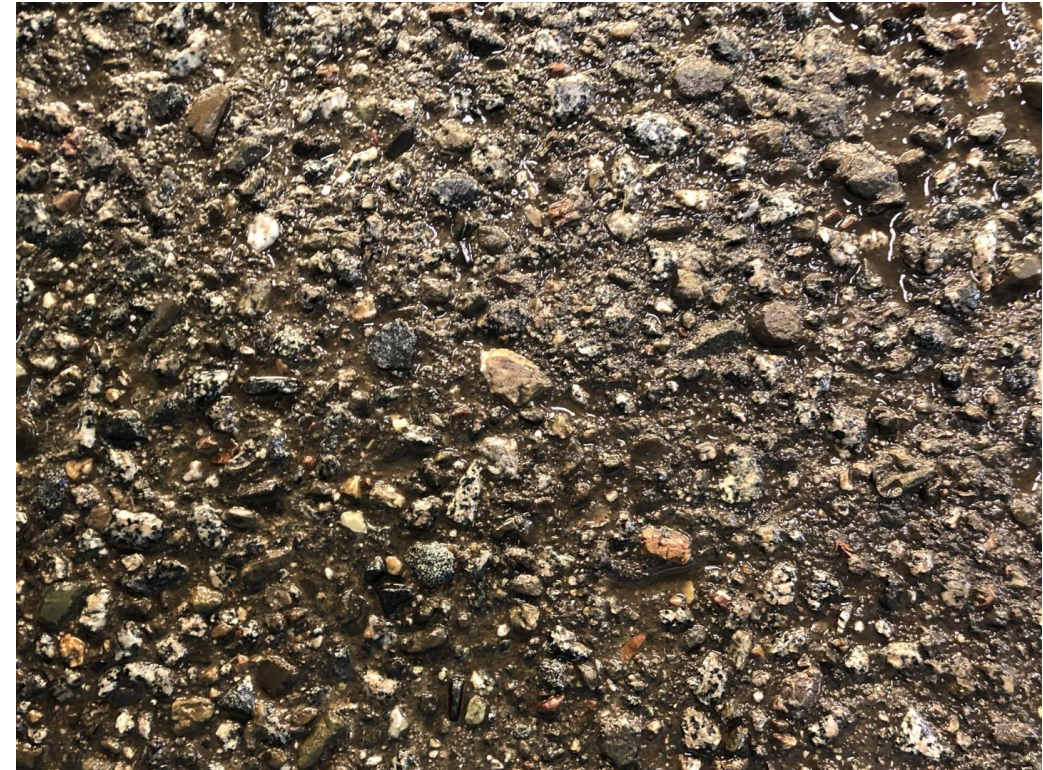
Normal Wear

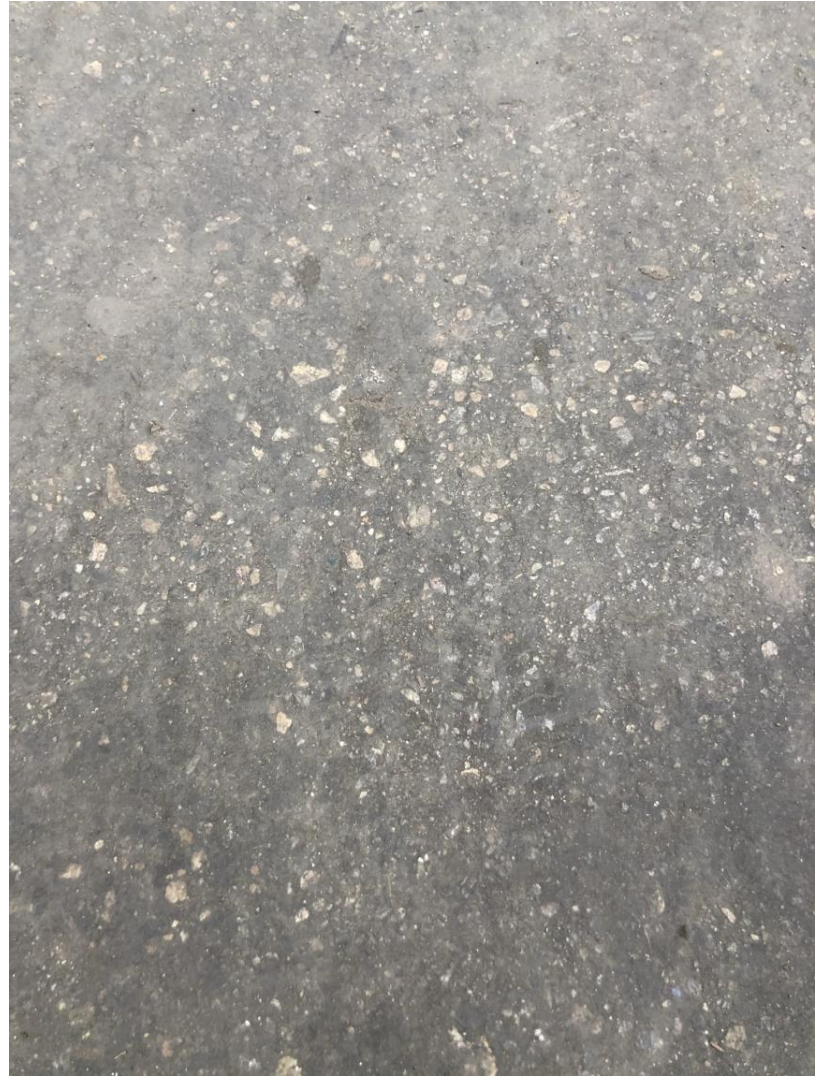
Chemical Attack

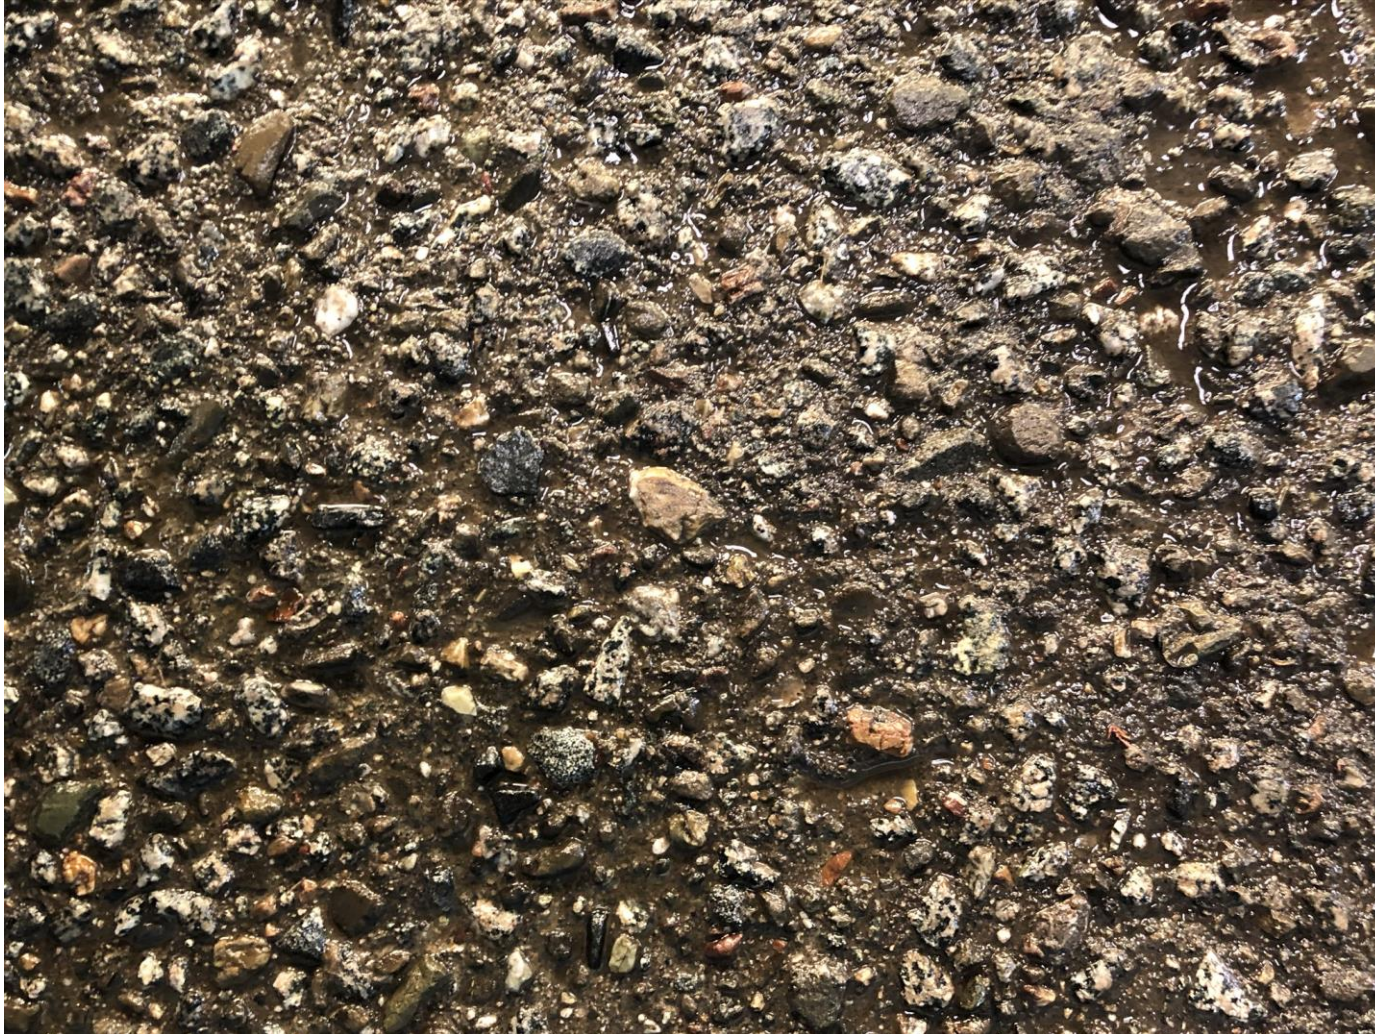
Normal Abrasion

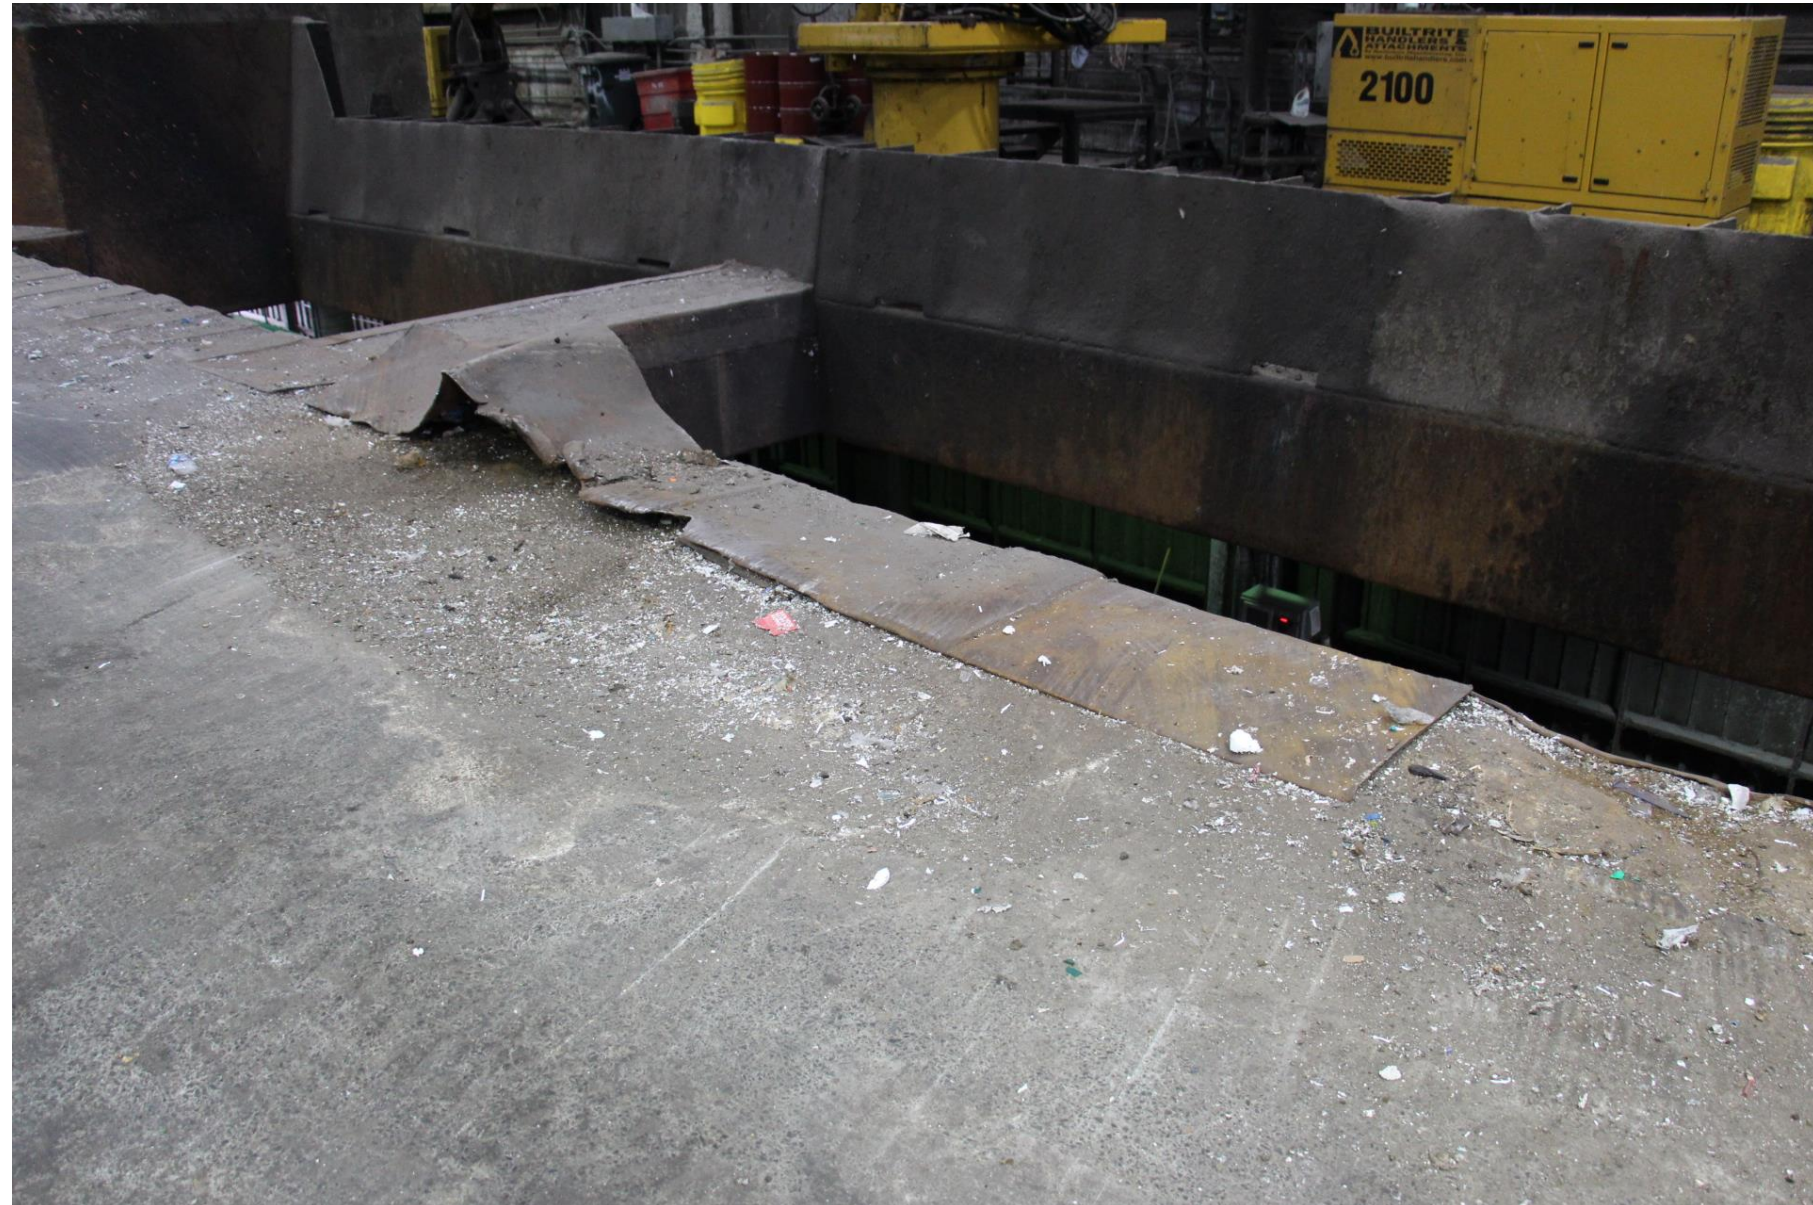
Steel around
port edge

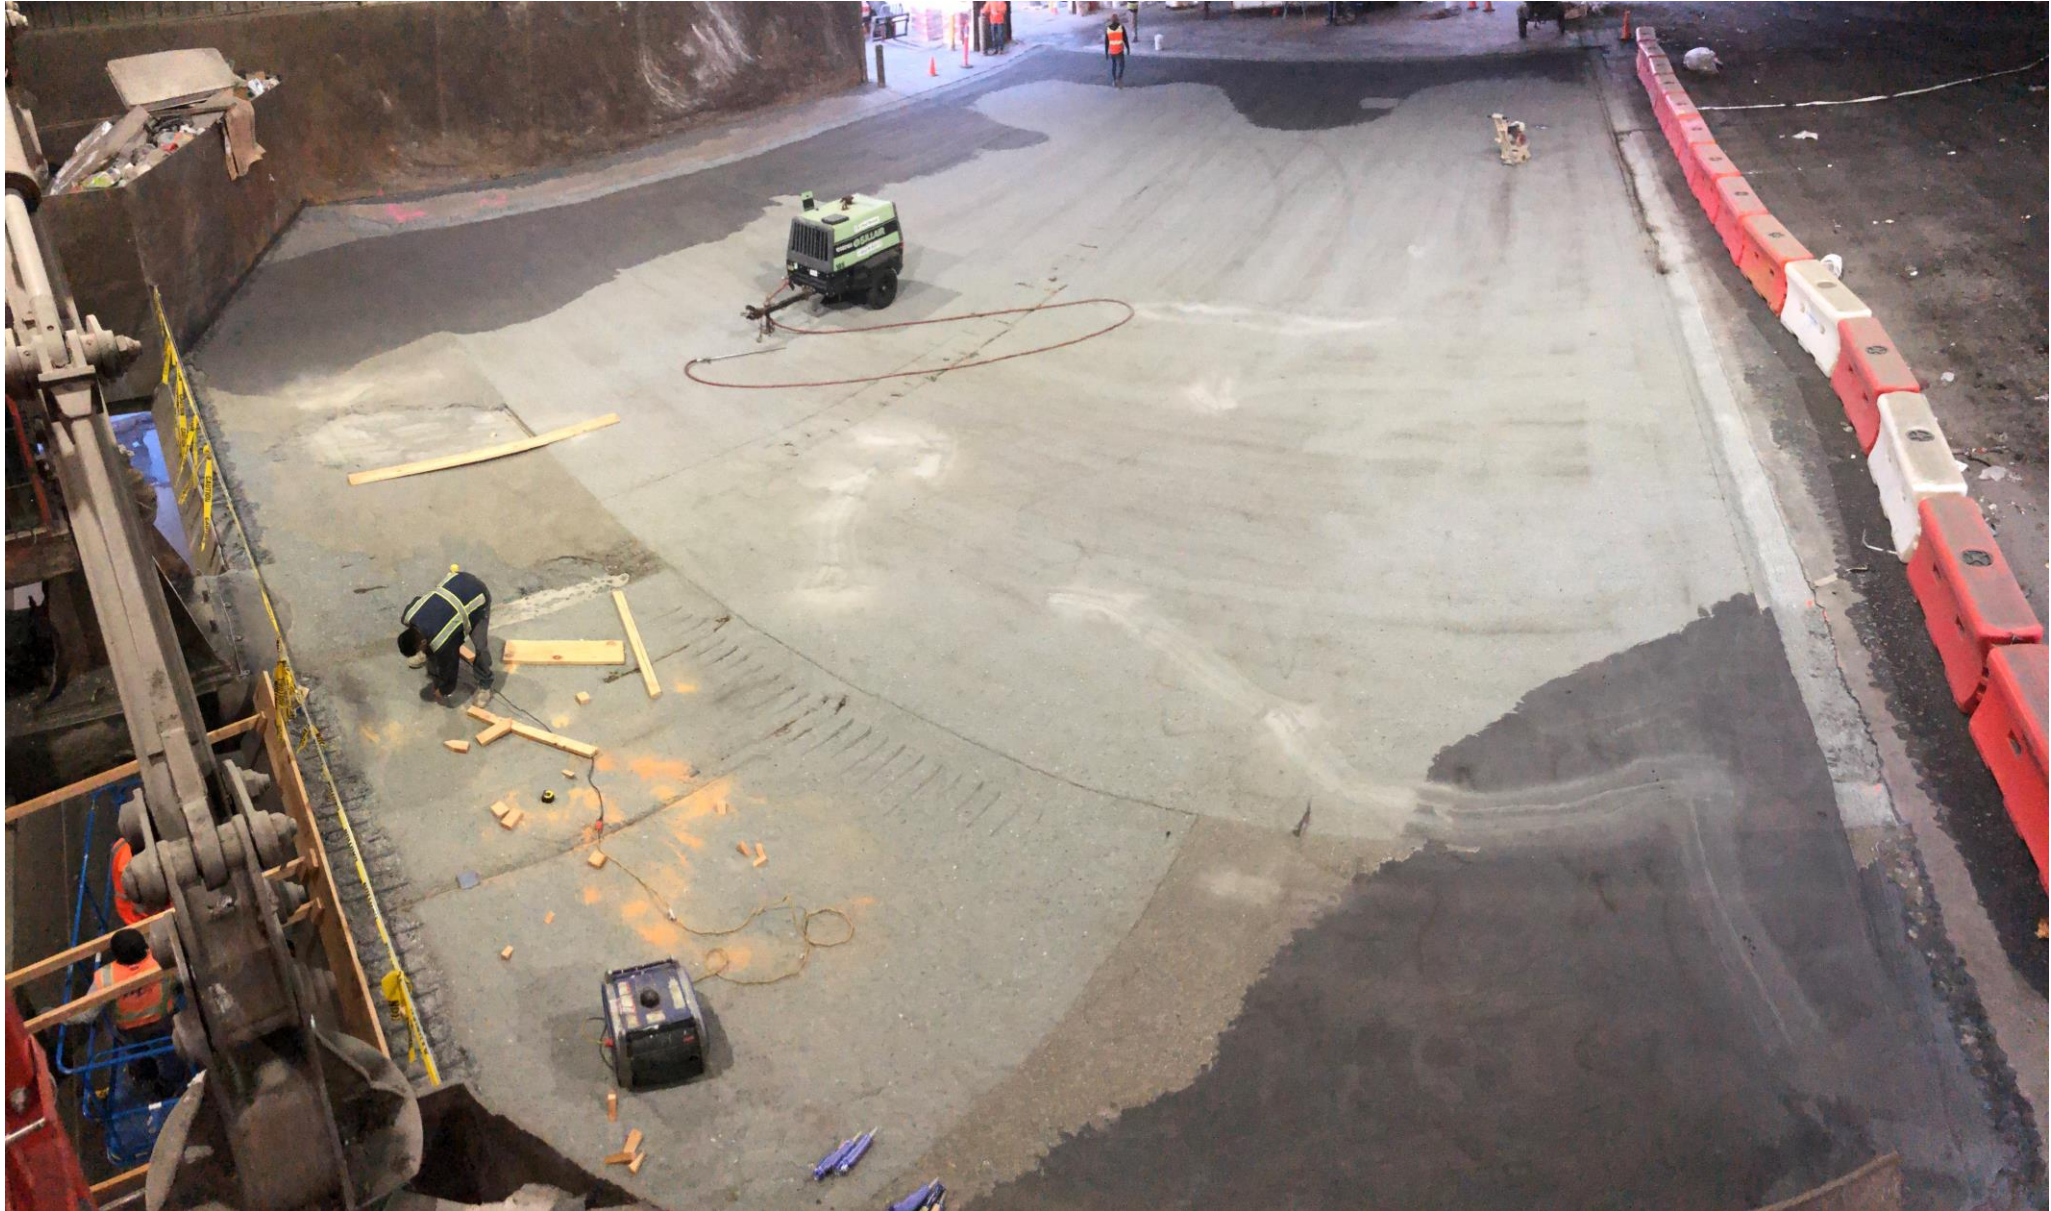
**The Floor
doesn't
wear
evenly**

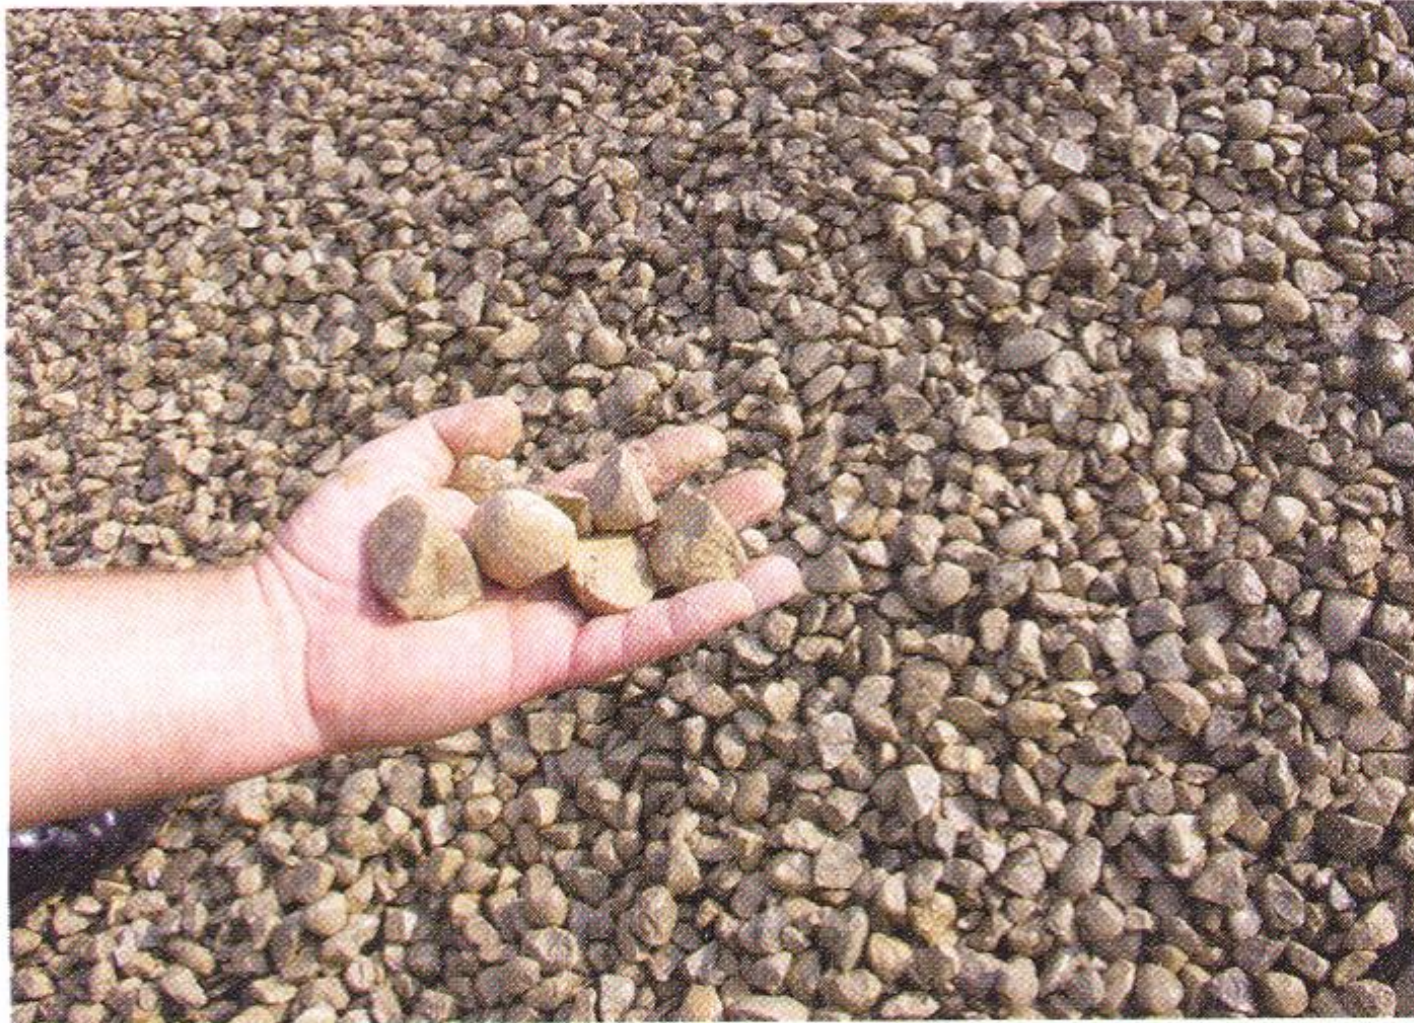
**Fig. 3: Coarse aggregate used for the distribution center concrete
(No. 467 stone [37.5 to 4.75 mm])**

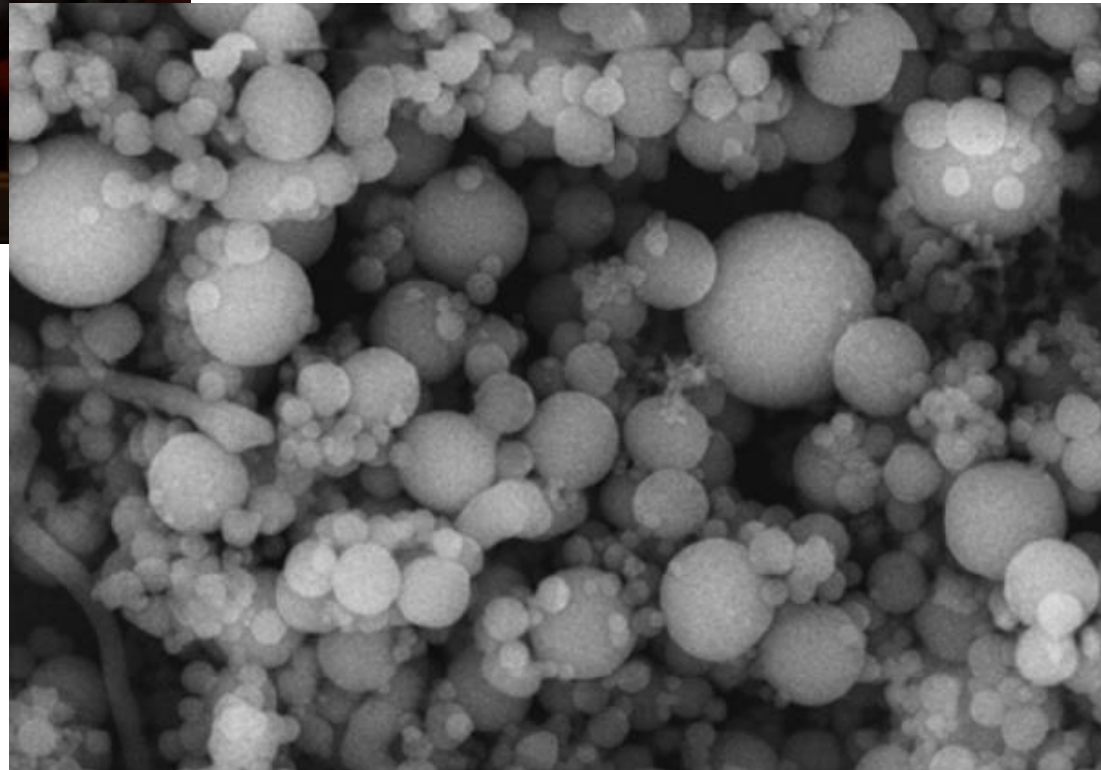
Silica Fume / Micro Silica

By product of Electric Arc
Furnaces used in making steel

**Also rounded and
1,000 times smaller
than cement particles.**

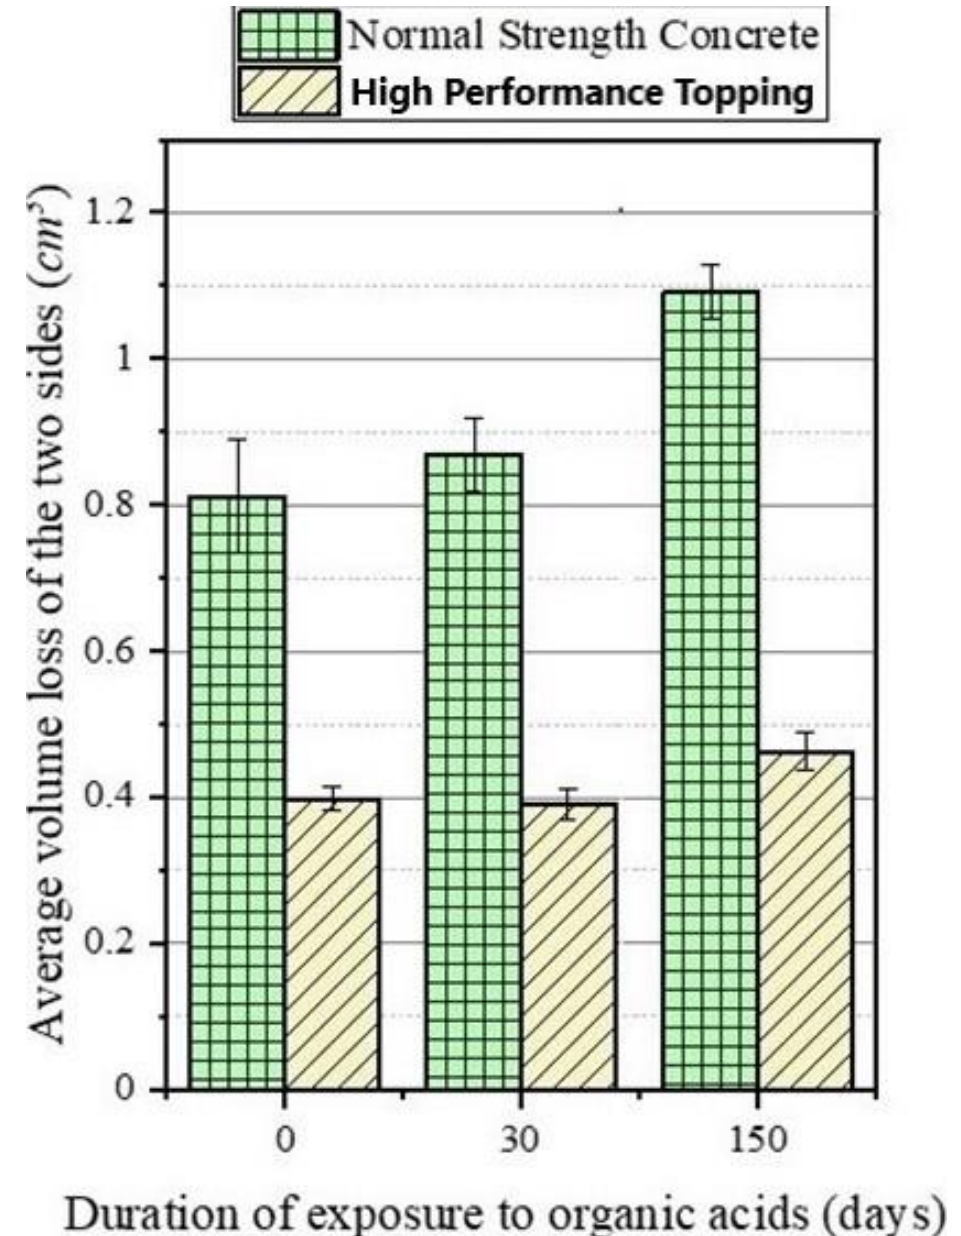
High Performance Topping:

15,000 psi

.27 w/c ratio

Calcined Bauxite Aggregate

◆ Surface life is 3-5x
