The Often-Overlooked Design Details of Transfer Stations

Florida SWANA, Summer 2024

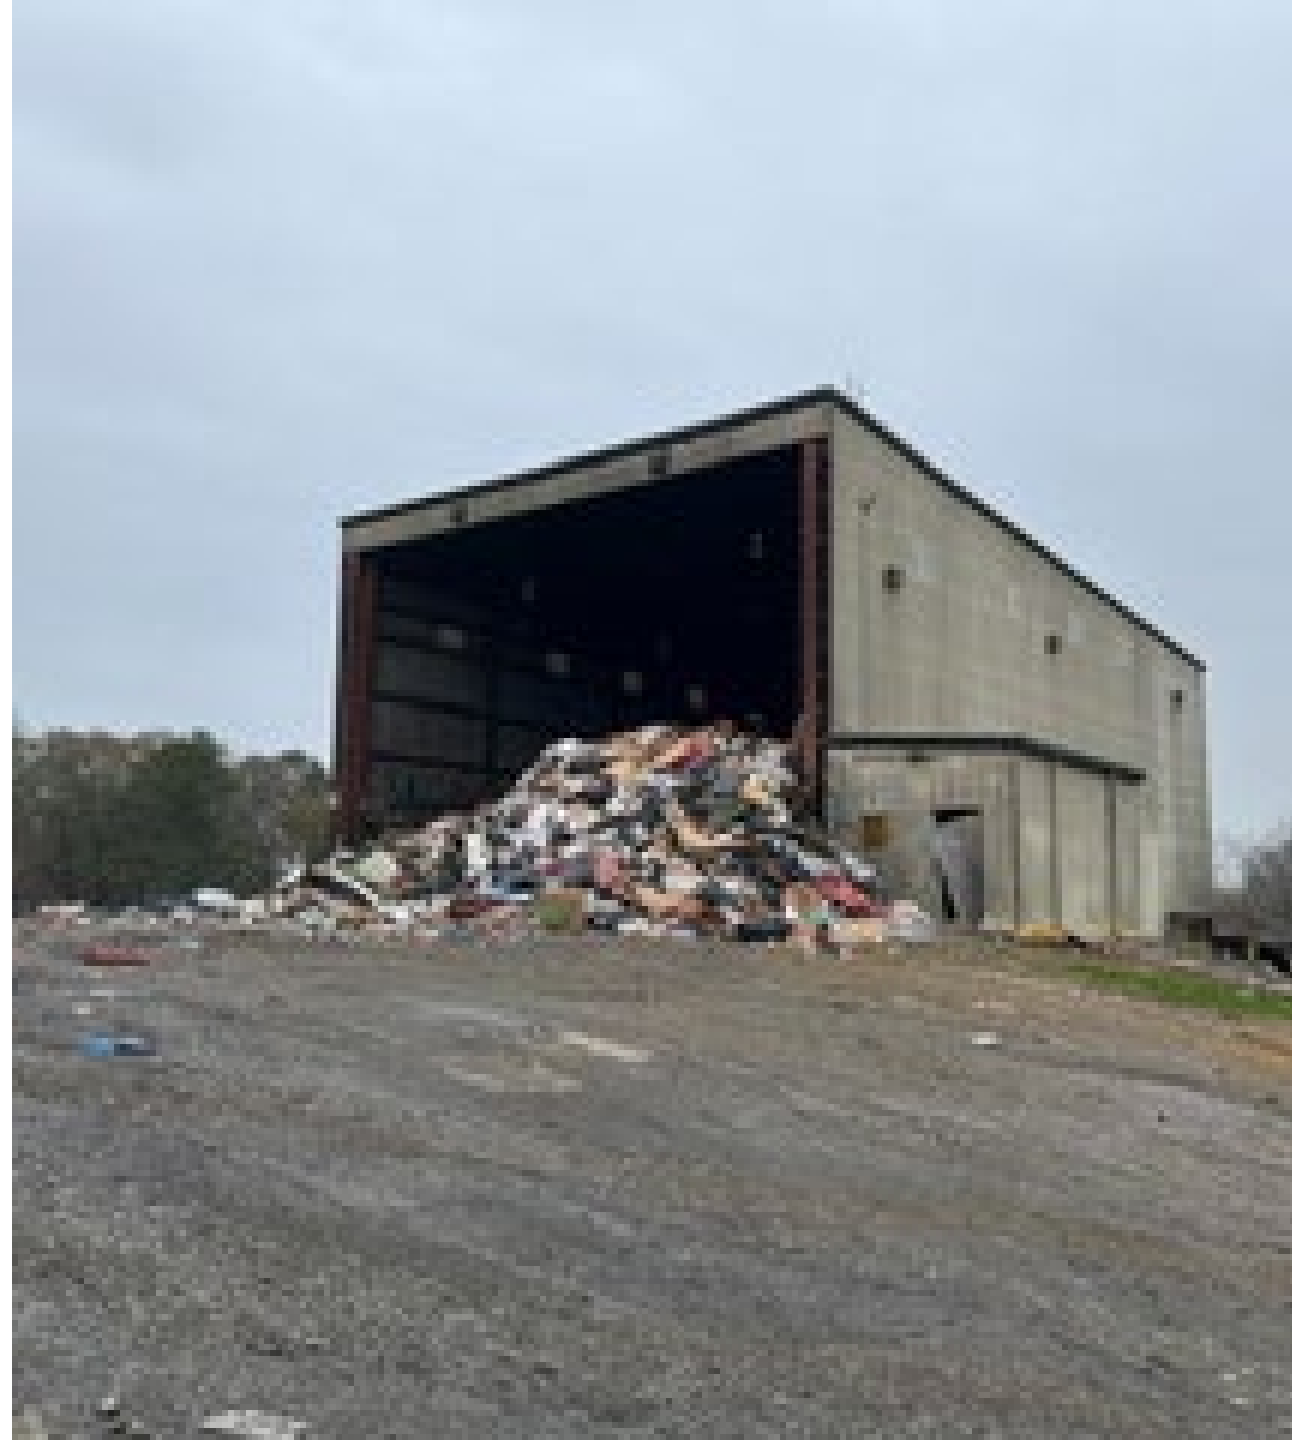
Waste Coming Through Wall

Leachate Escaping Station

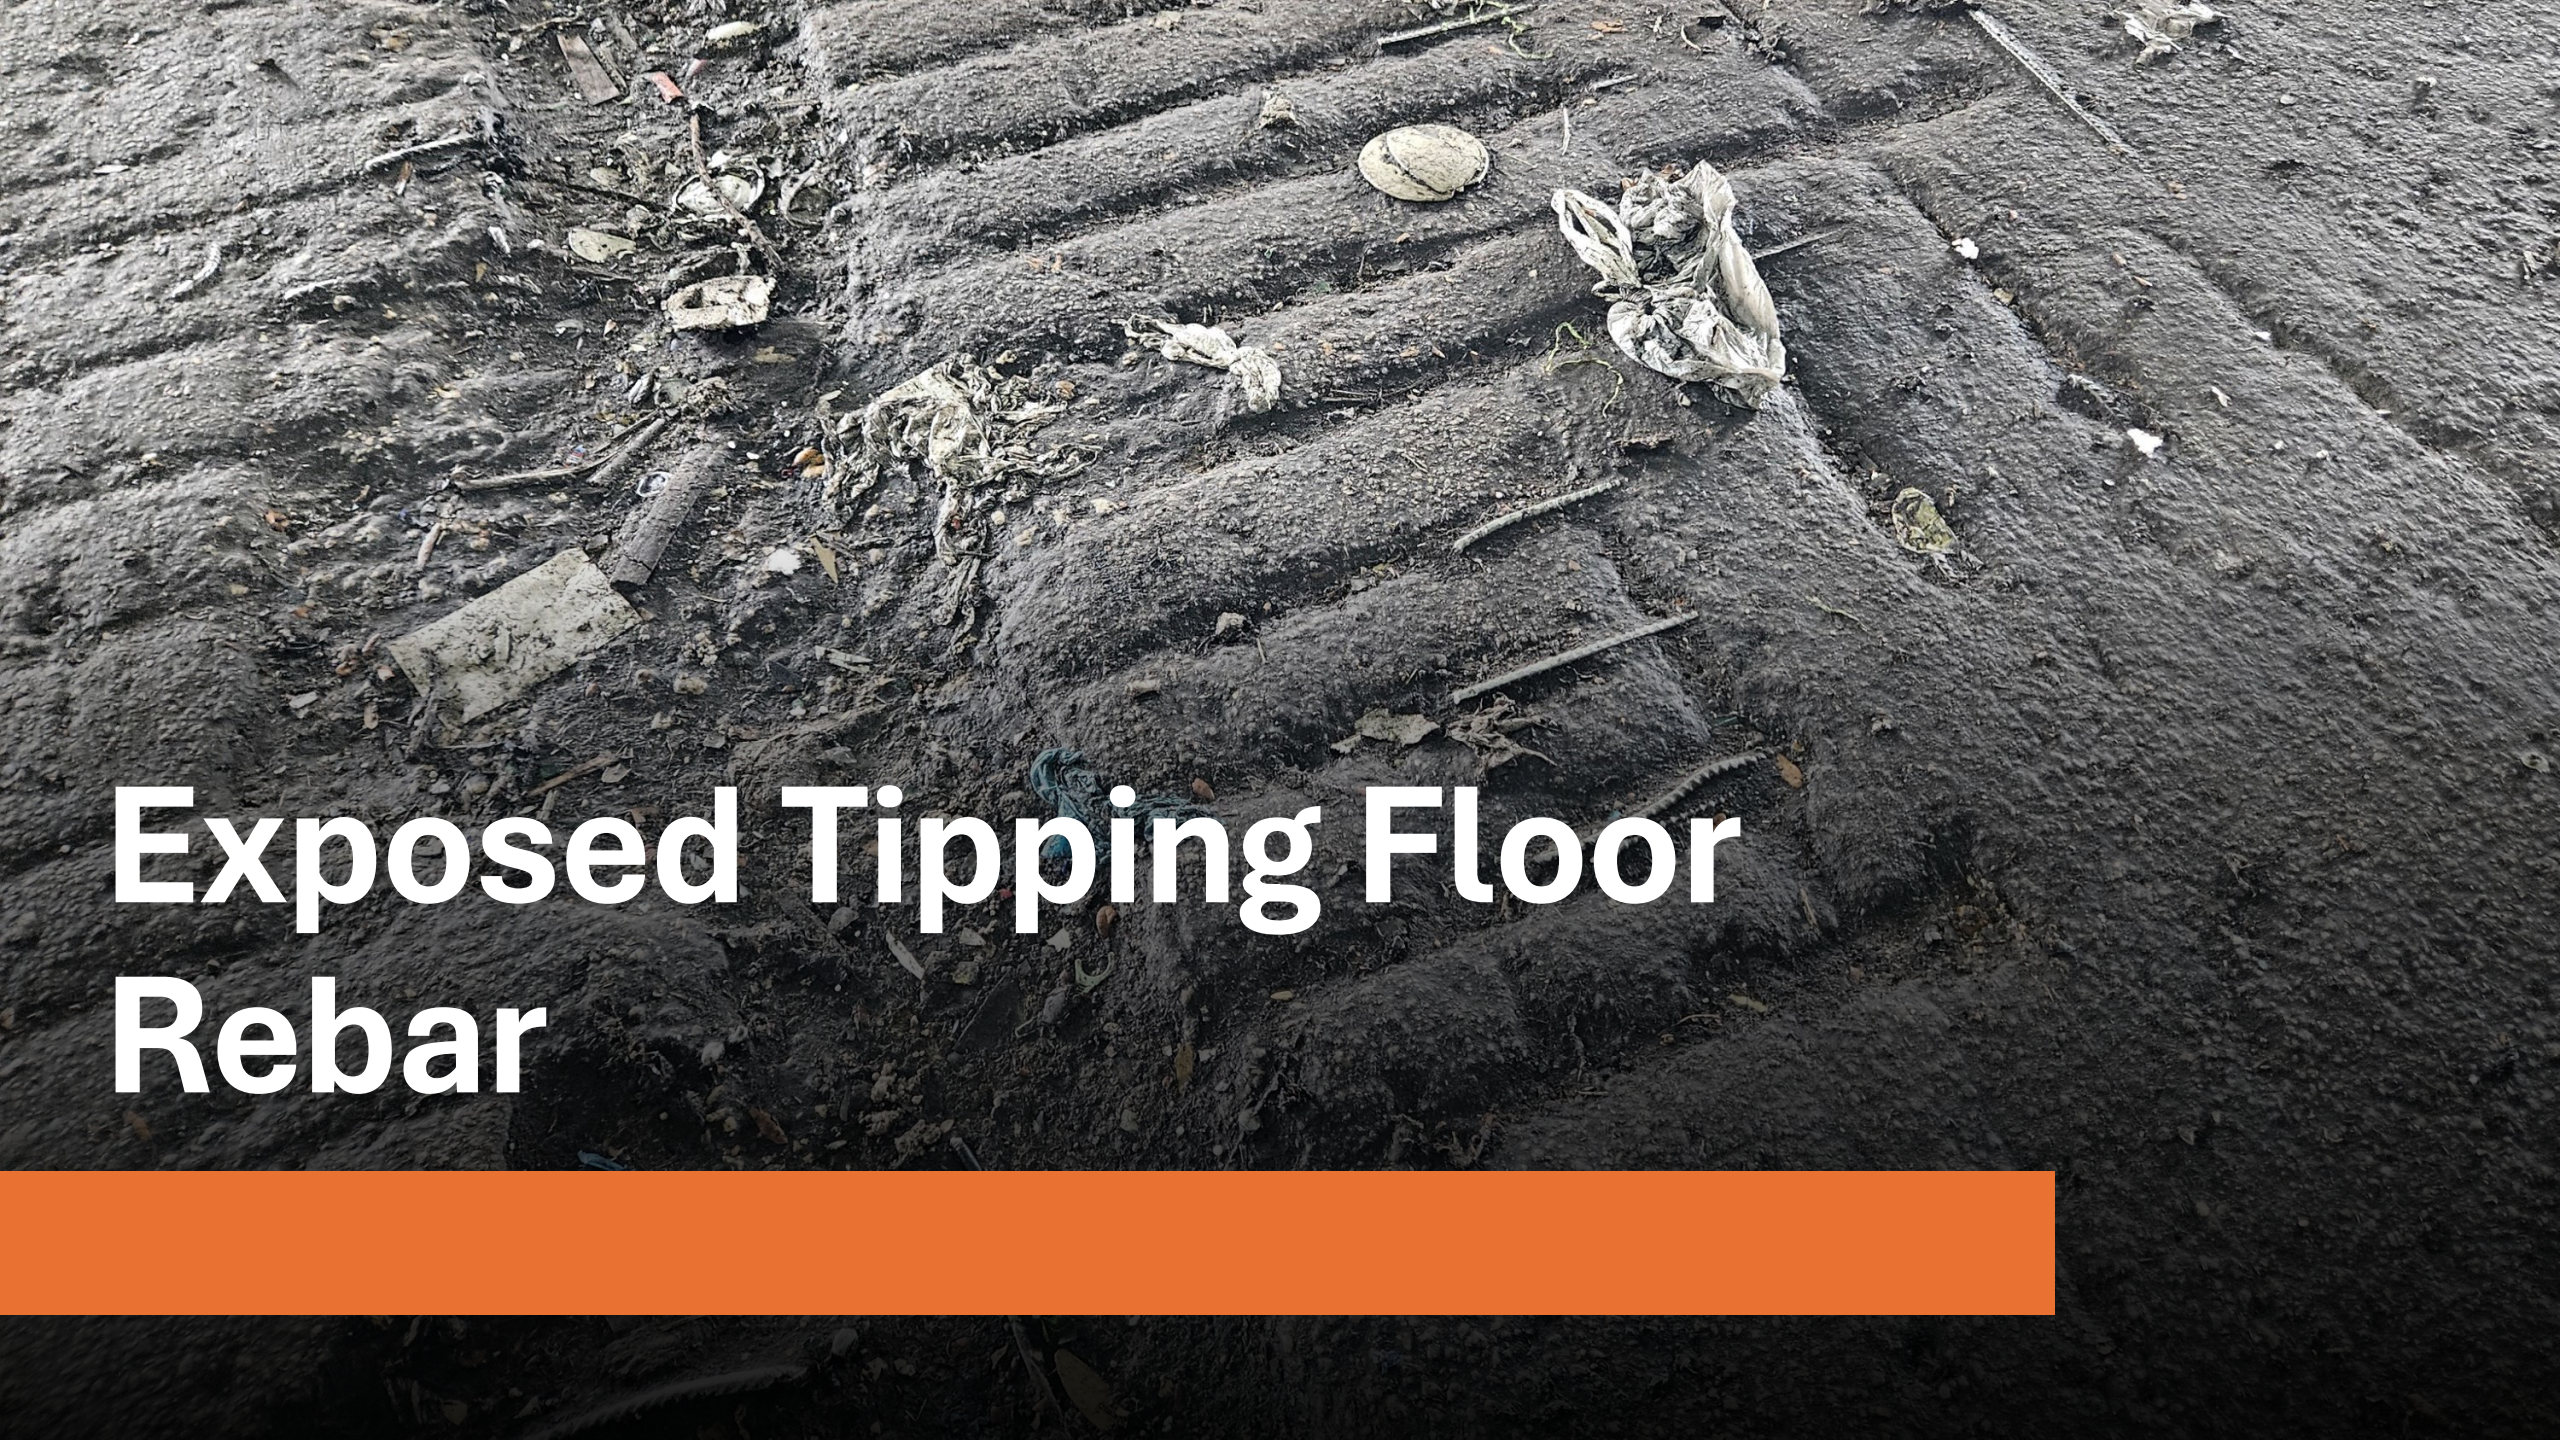
A photograph showing a dark, textured concrete tipping floor. The floor is covered with various pieces of debris, including plastic bags, a metal can, and some wood. Several metal rebar rods are visible, protruding from the surface of the concrete. The overall scene suggests a construction site or a waste management area where the concrete has been exposed.

Exposed Tipping Floor Rebar

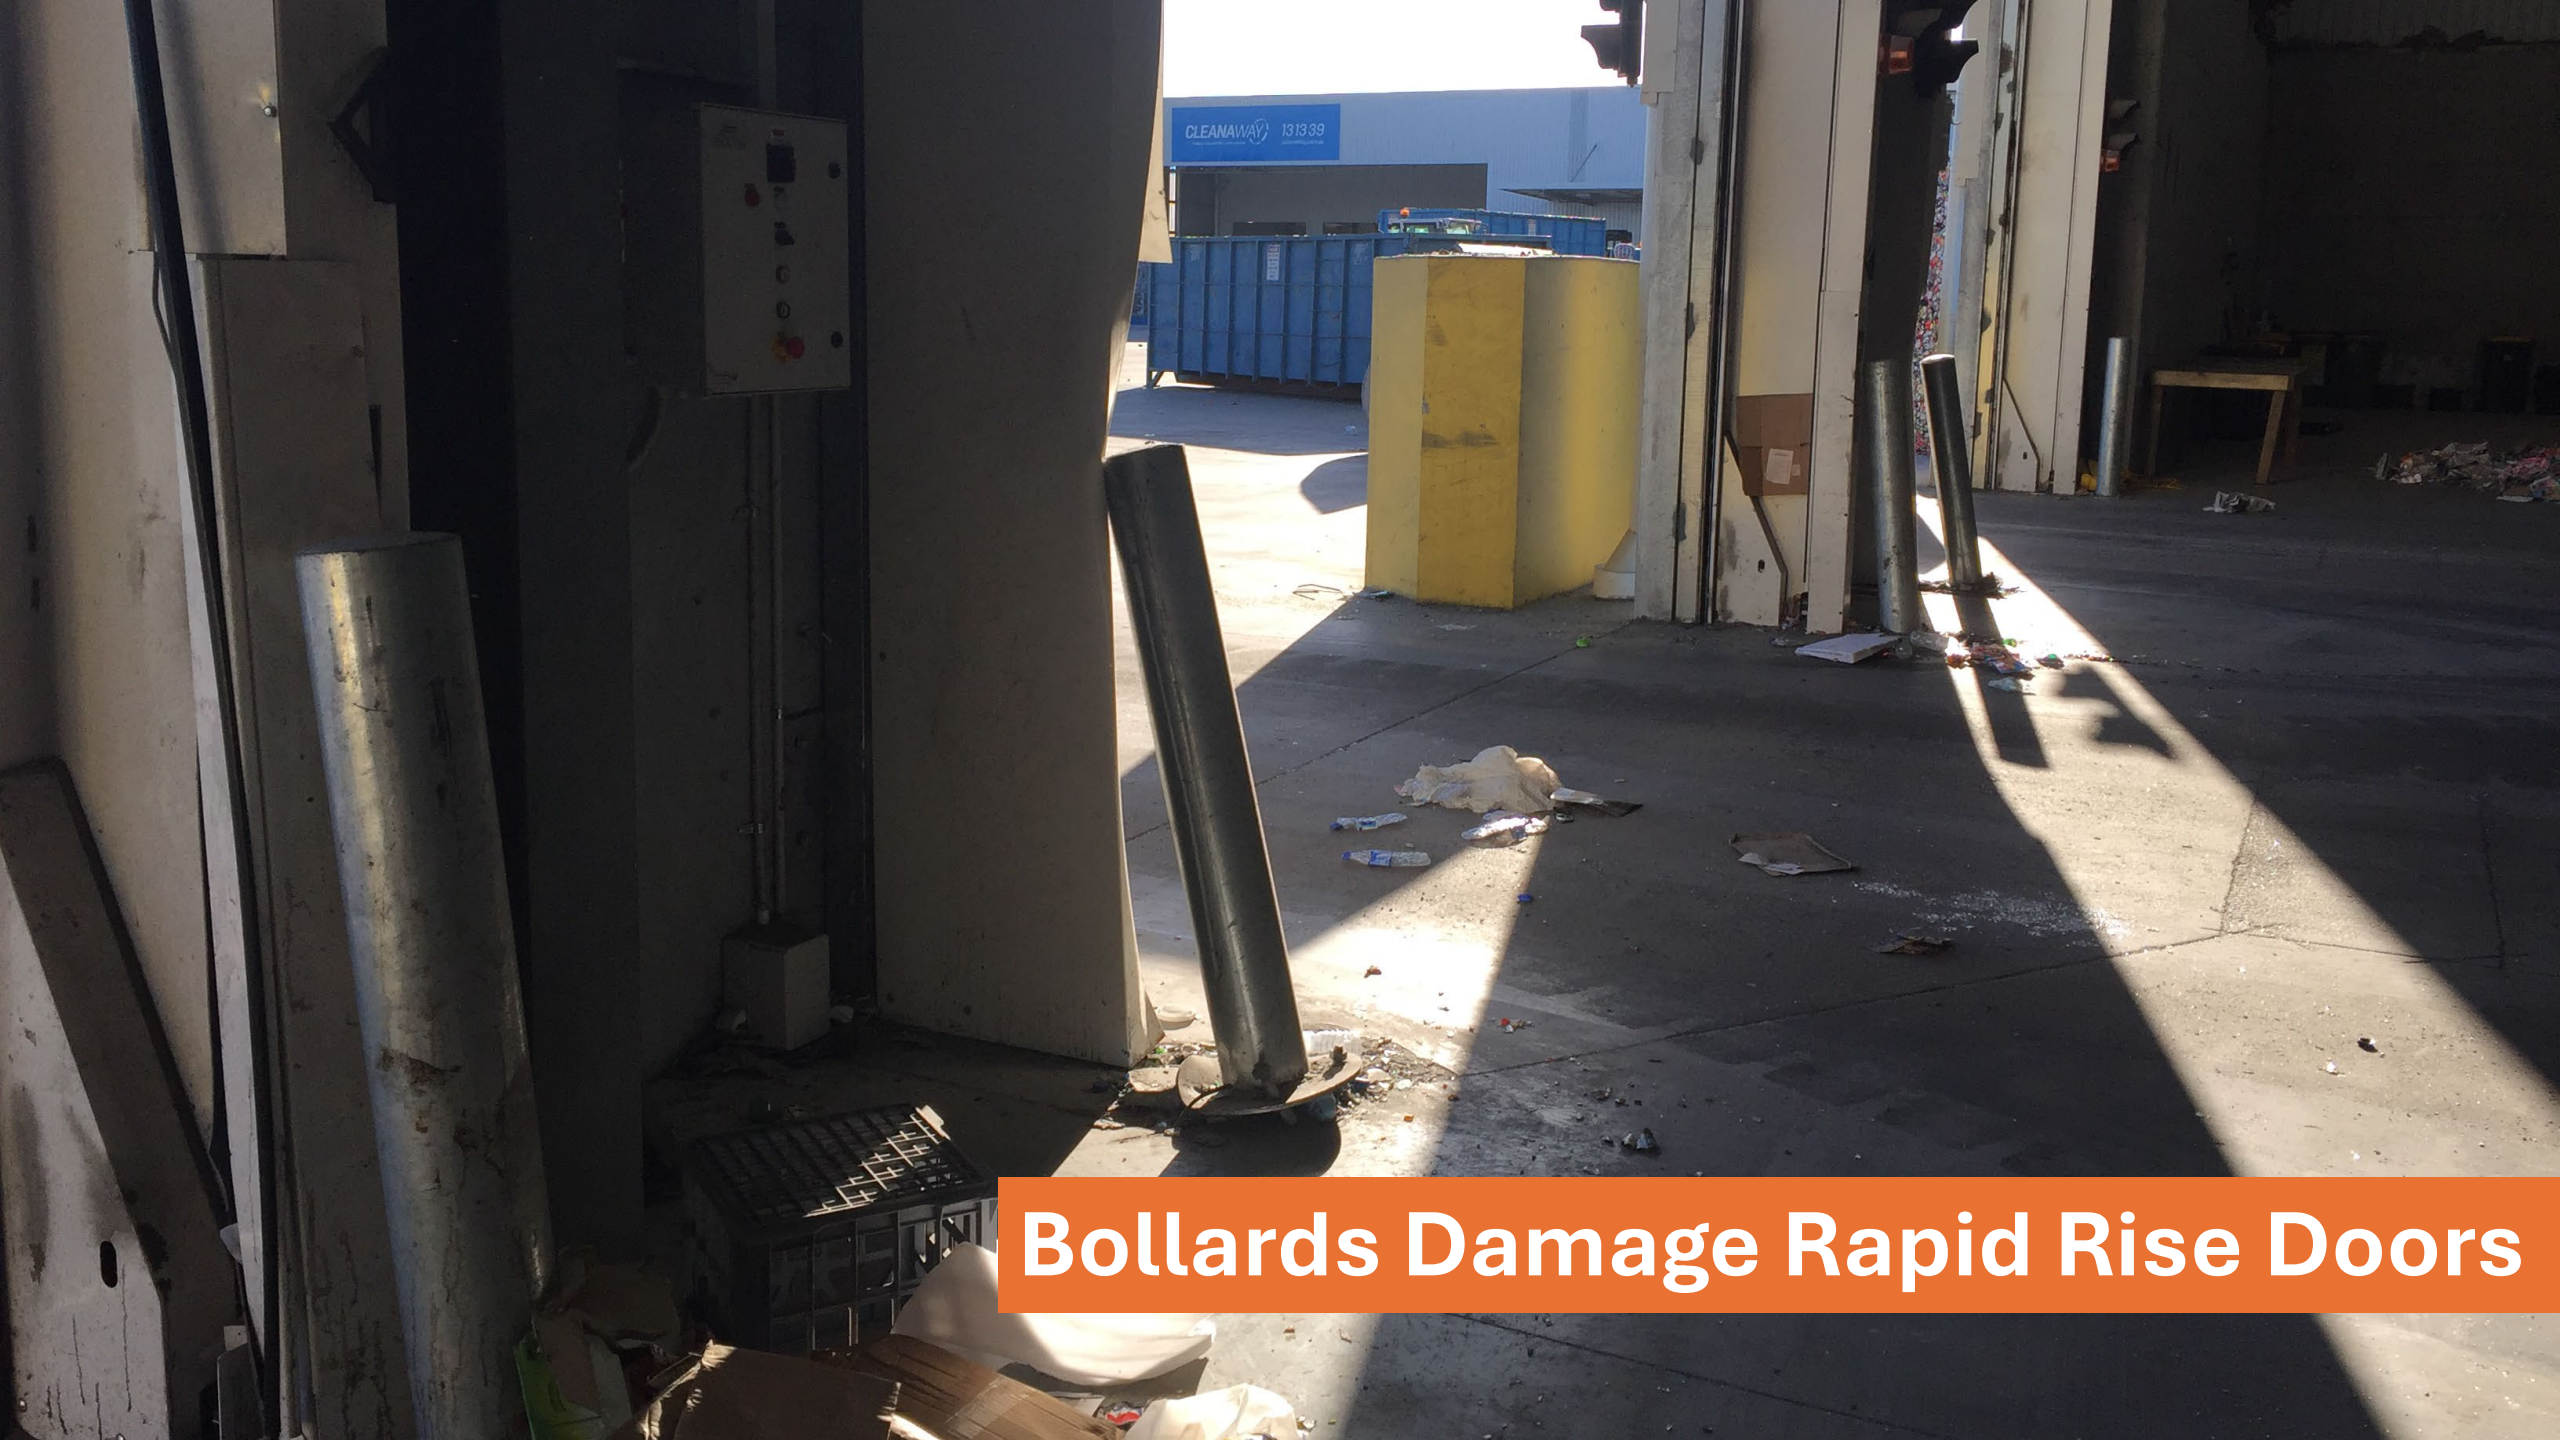
Bollards Damage Rapid Rise Doors

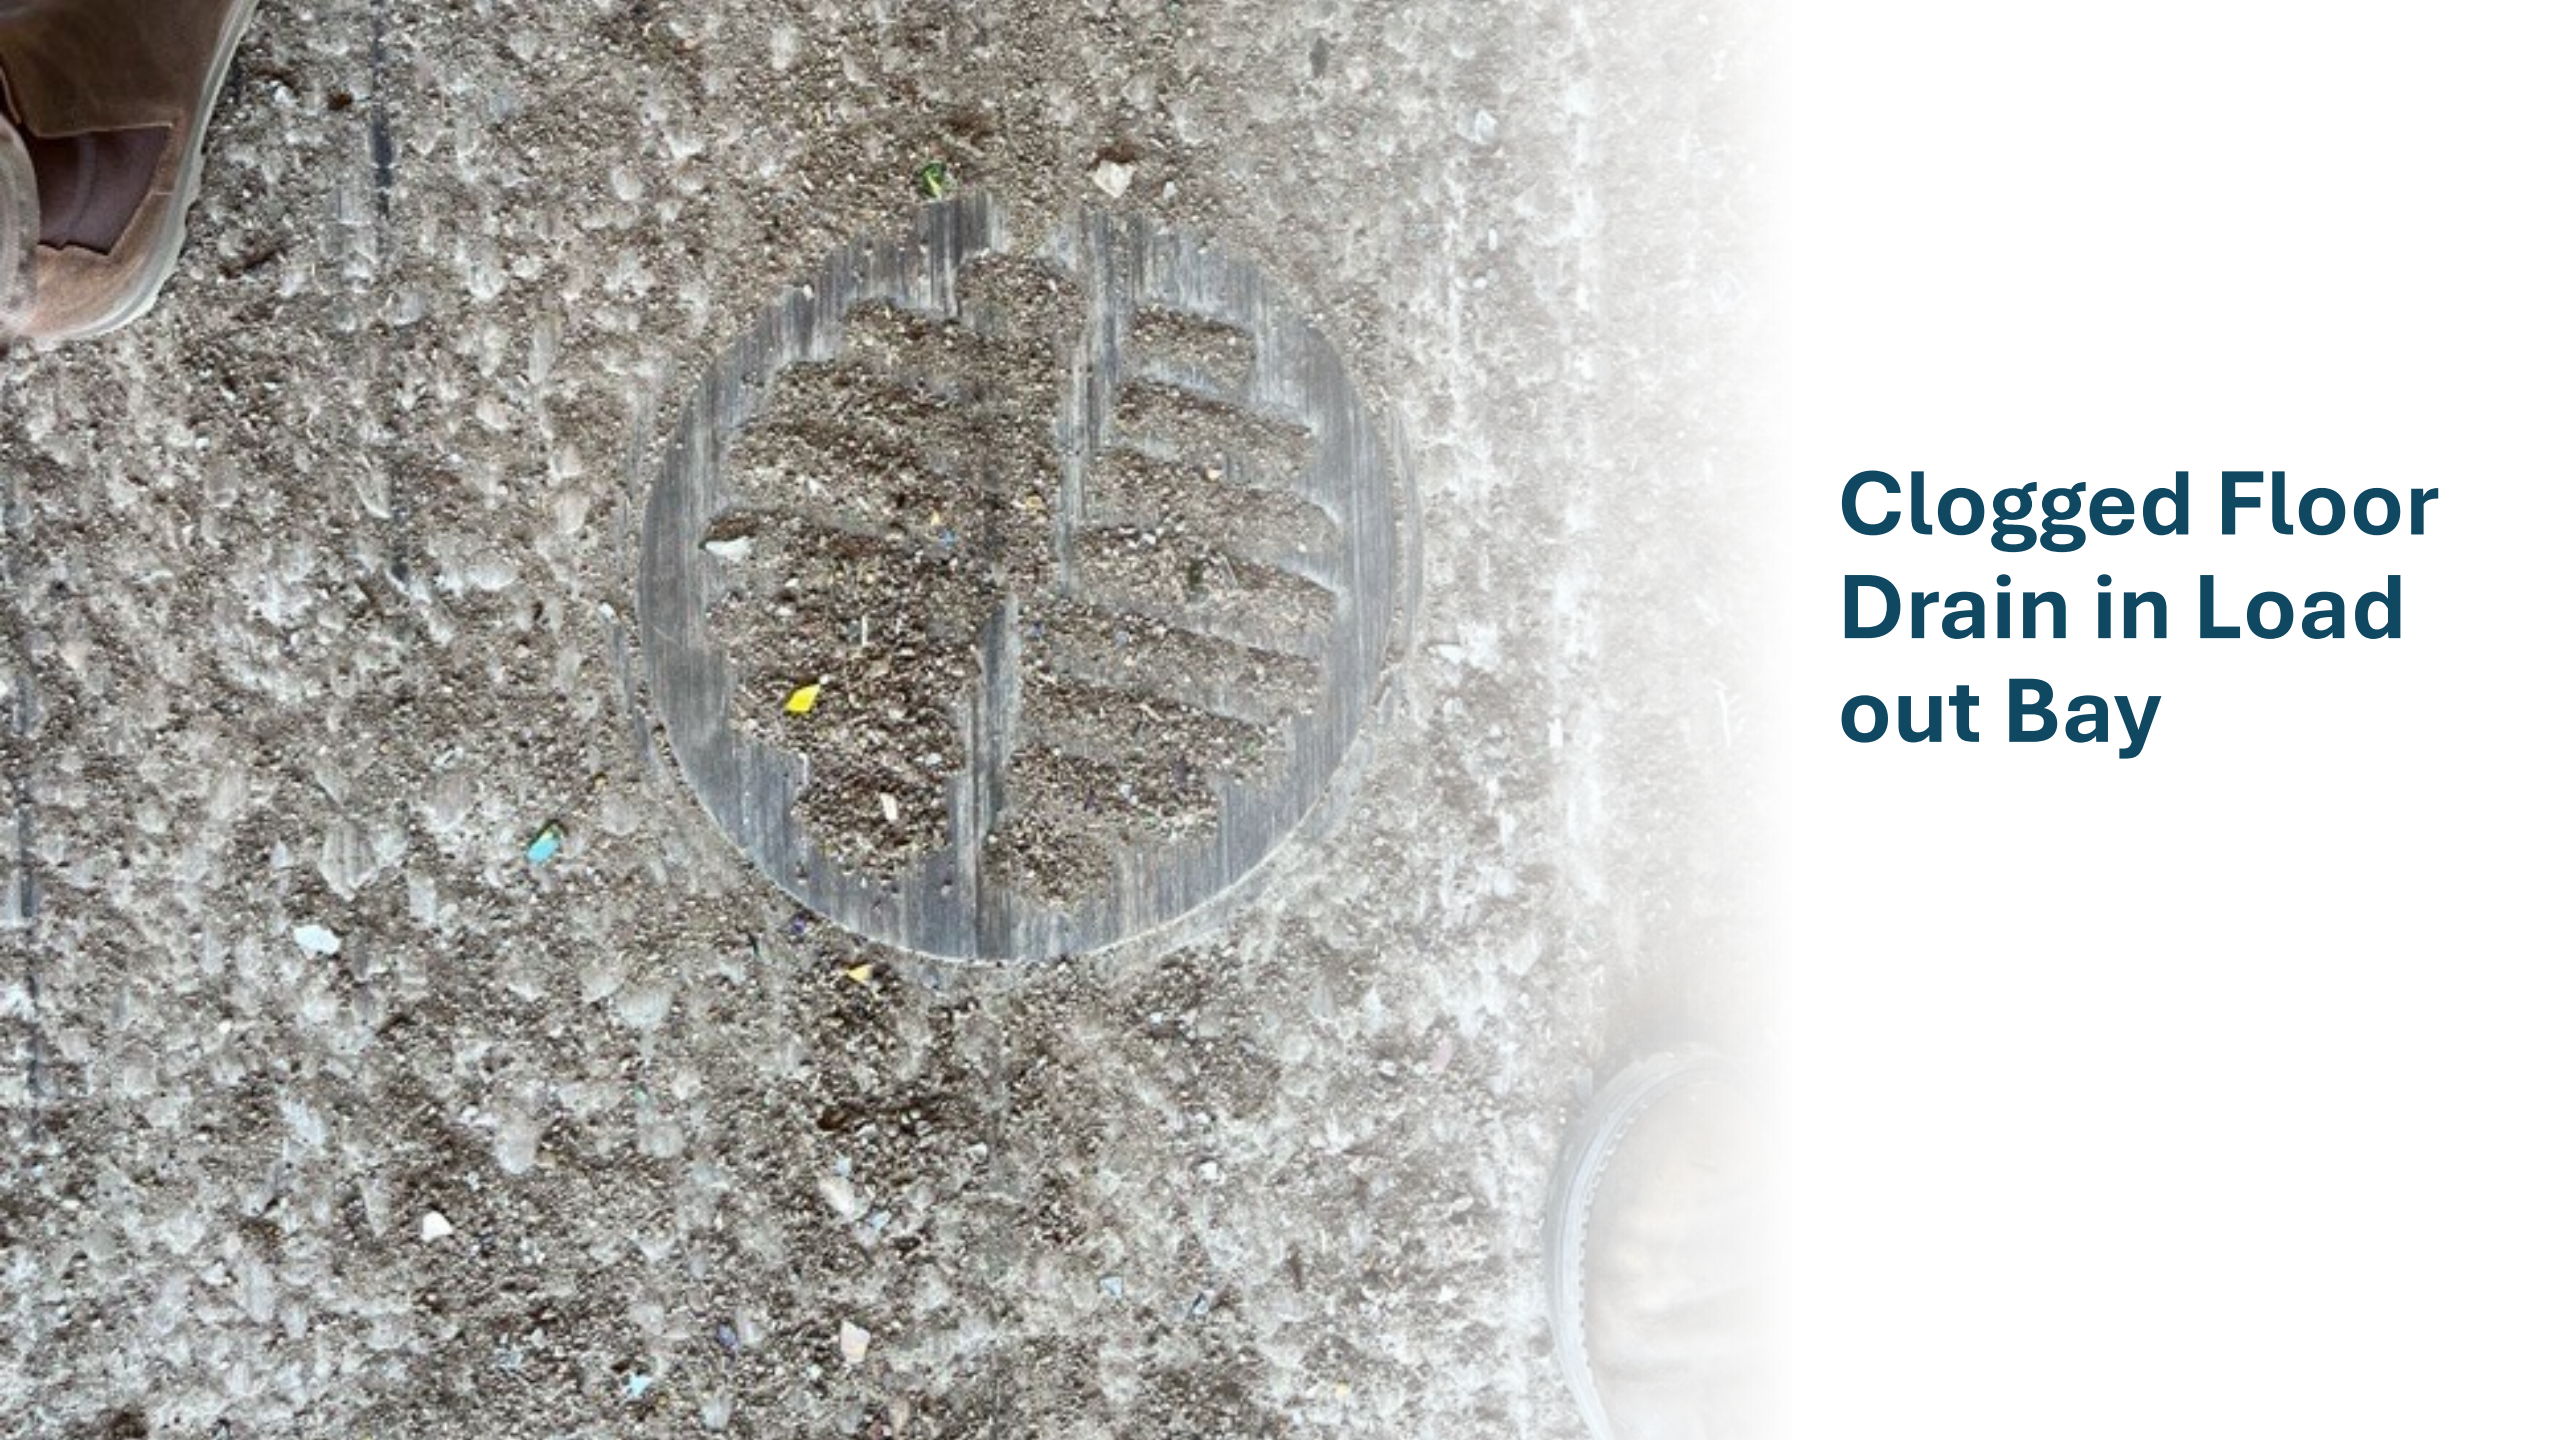
**Clogged Floor
Drain in Load
out Bay**
