Challenges in Water Management Solutions in the Lee-Hendry County Regional Solid Waste Disposal Facility

Solid Waste Association of North America (SWANA) Conference
February 24th, 2024

History of the Facility

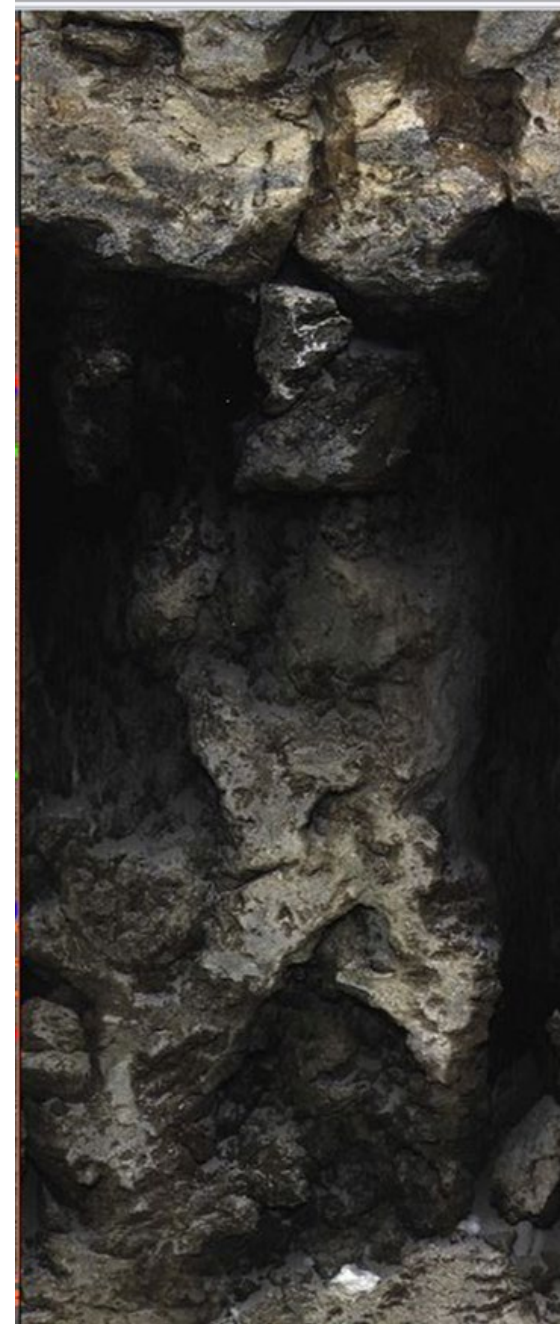
Boulder
Zone

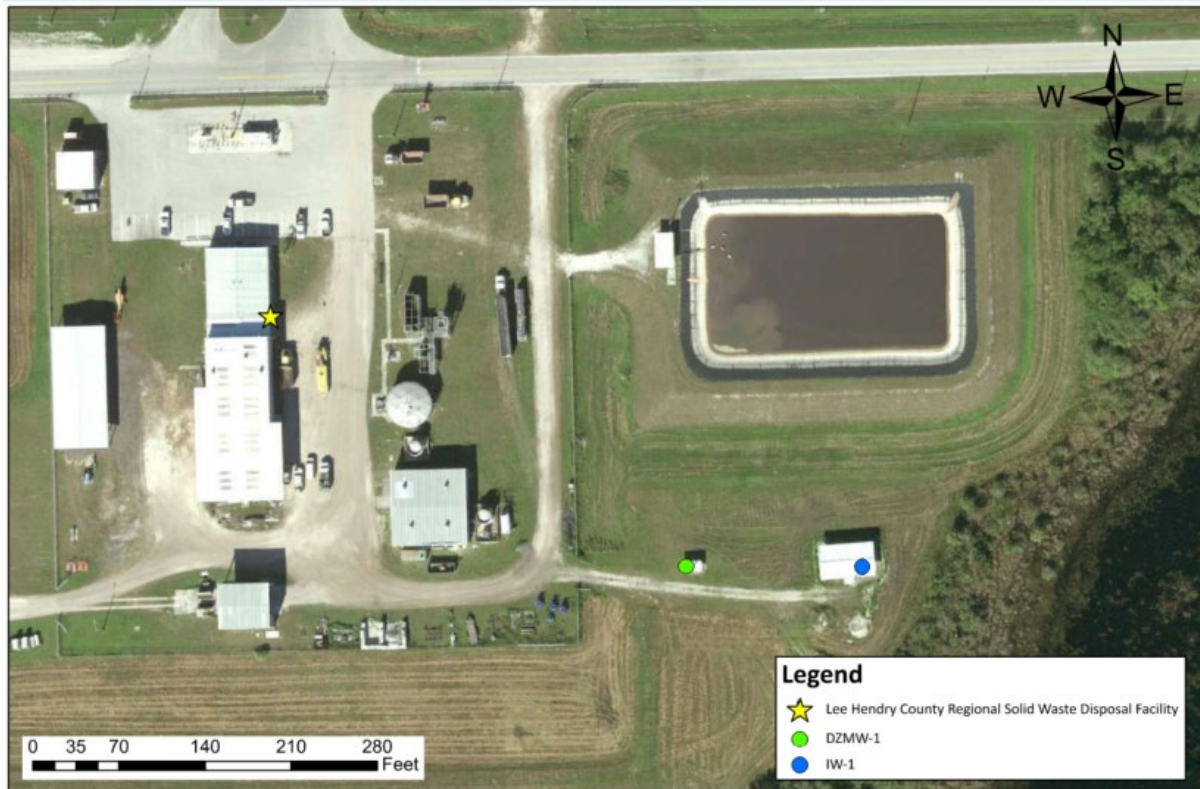
- **Number of injection wells:** One (1)
Industrial Injection Well
- **Well capacity (volume injected):** 1.32 MGD
- Constructed in year 2011
- Fluid-filled annular space

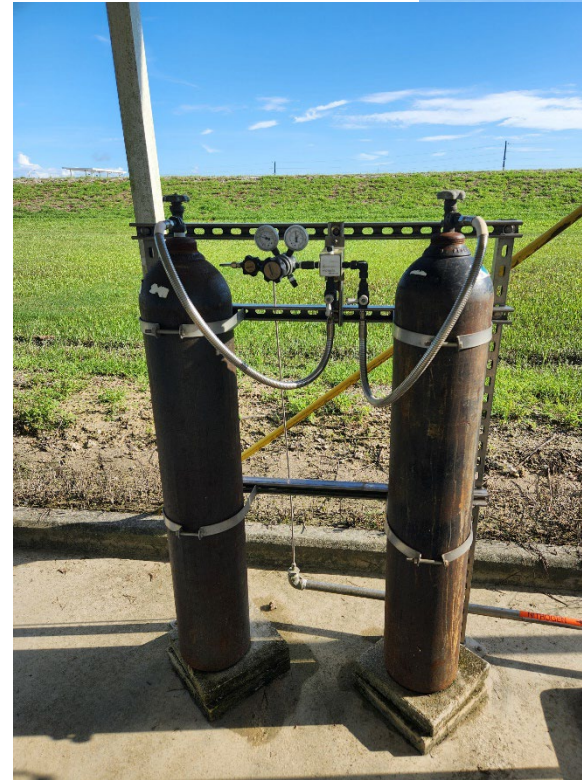
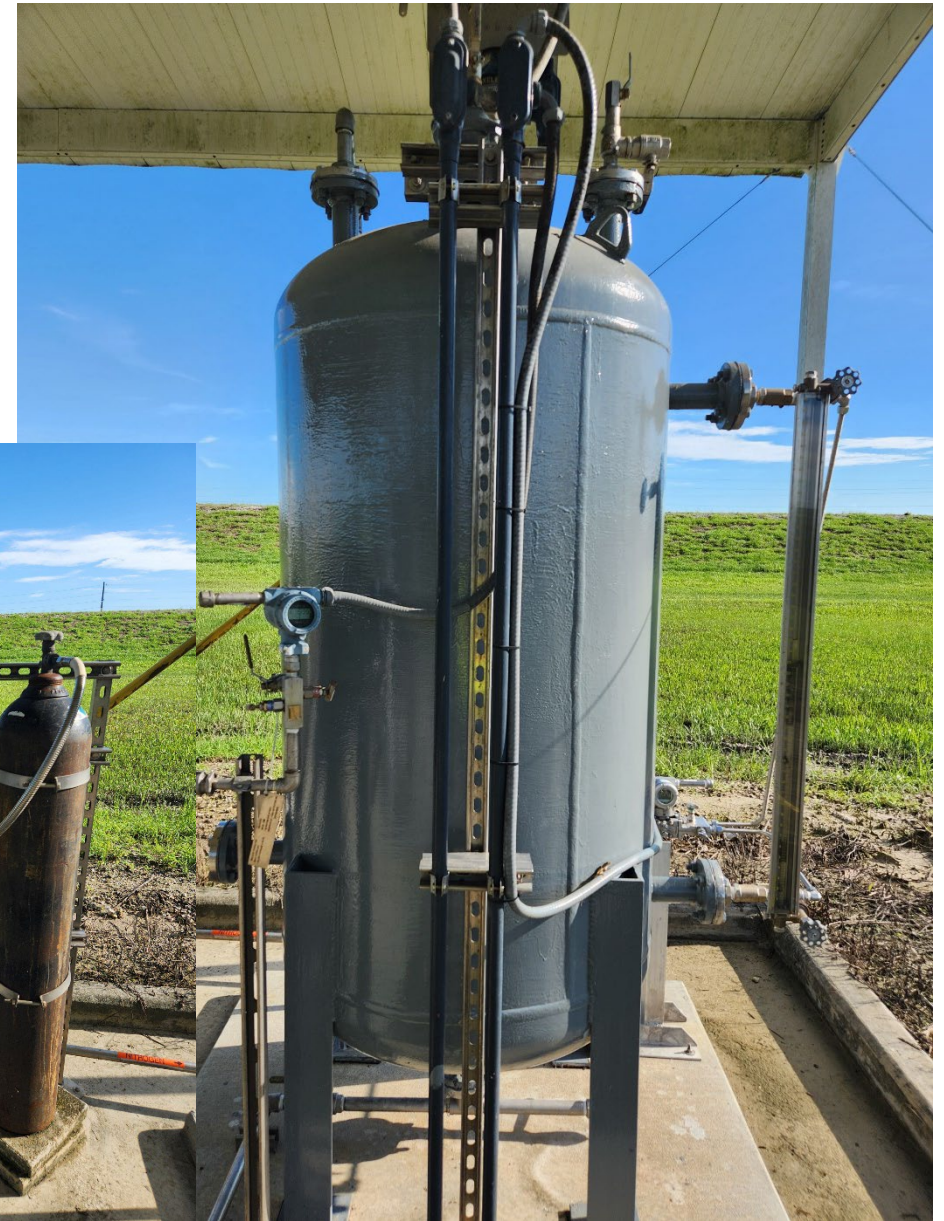
- Fluid-filled annular space with water containing a corrosion inhibitor solution (1% **Baracor**)
- Annulus pressure system provides pressure equalization in the annulus between the injection tubing and final casing
- Consists of an annulus pressure tank and two nitrogen cylinders.

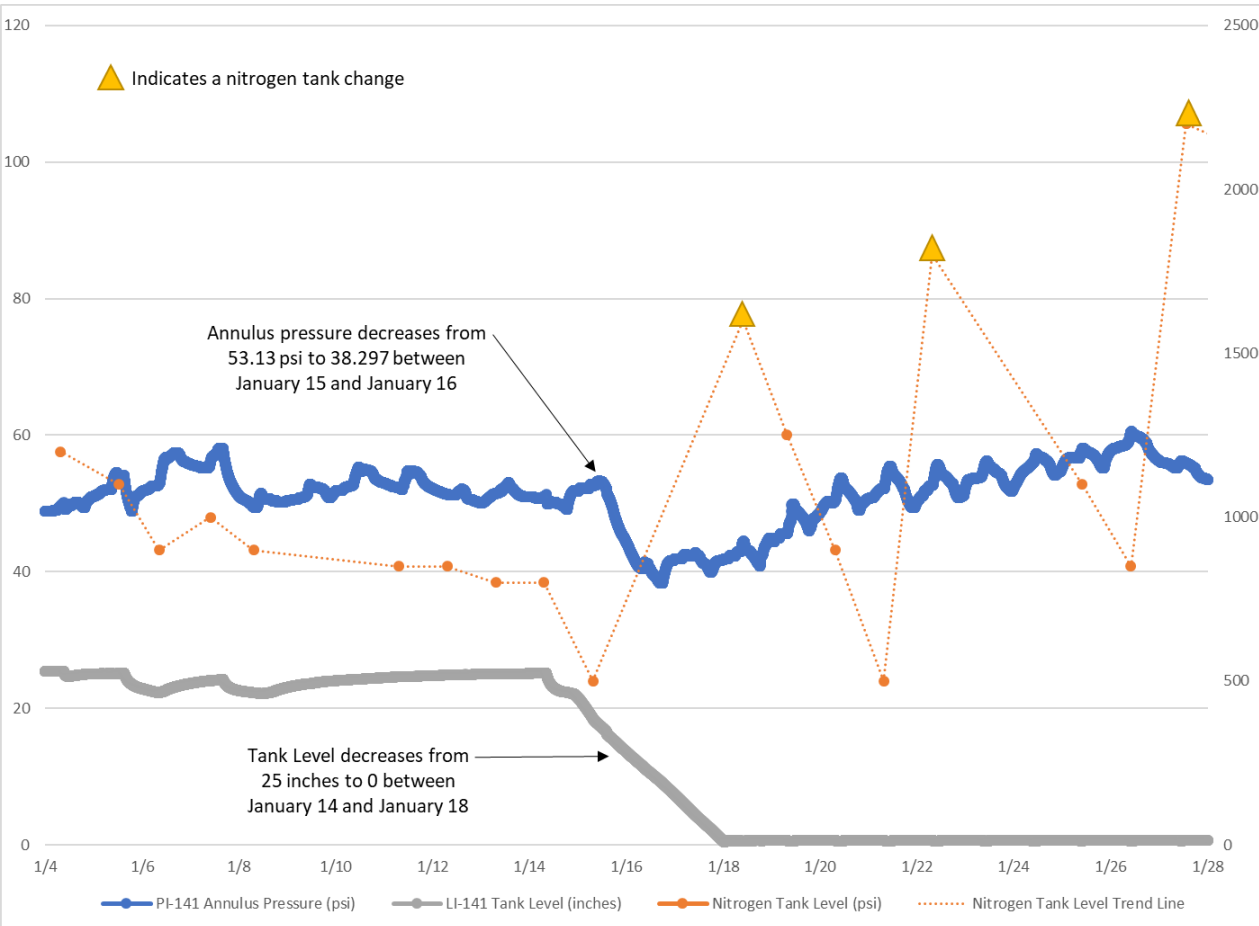
- An annulus fluid loss was experienced between January 15 and January 16, 2021.
- By January 18, 2021, all the 1% Baracor was lost.
- Increased Nitrogen usage.

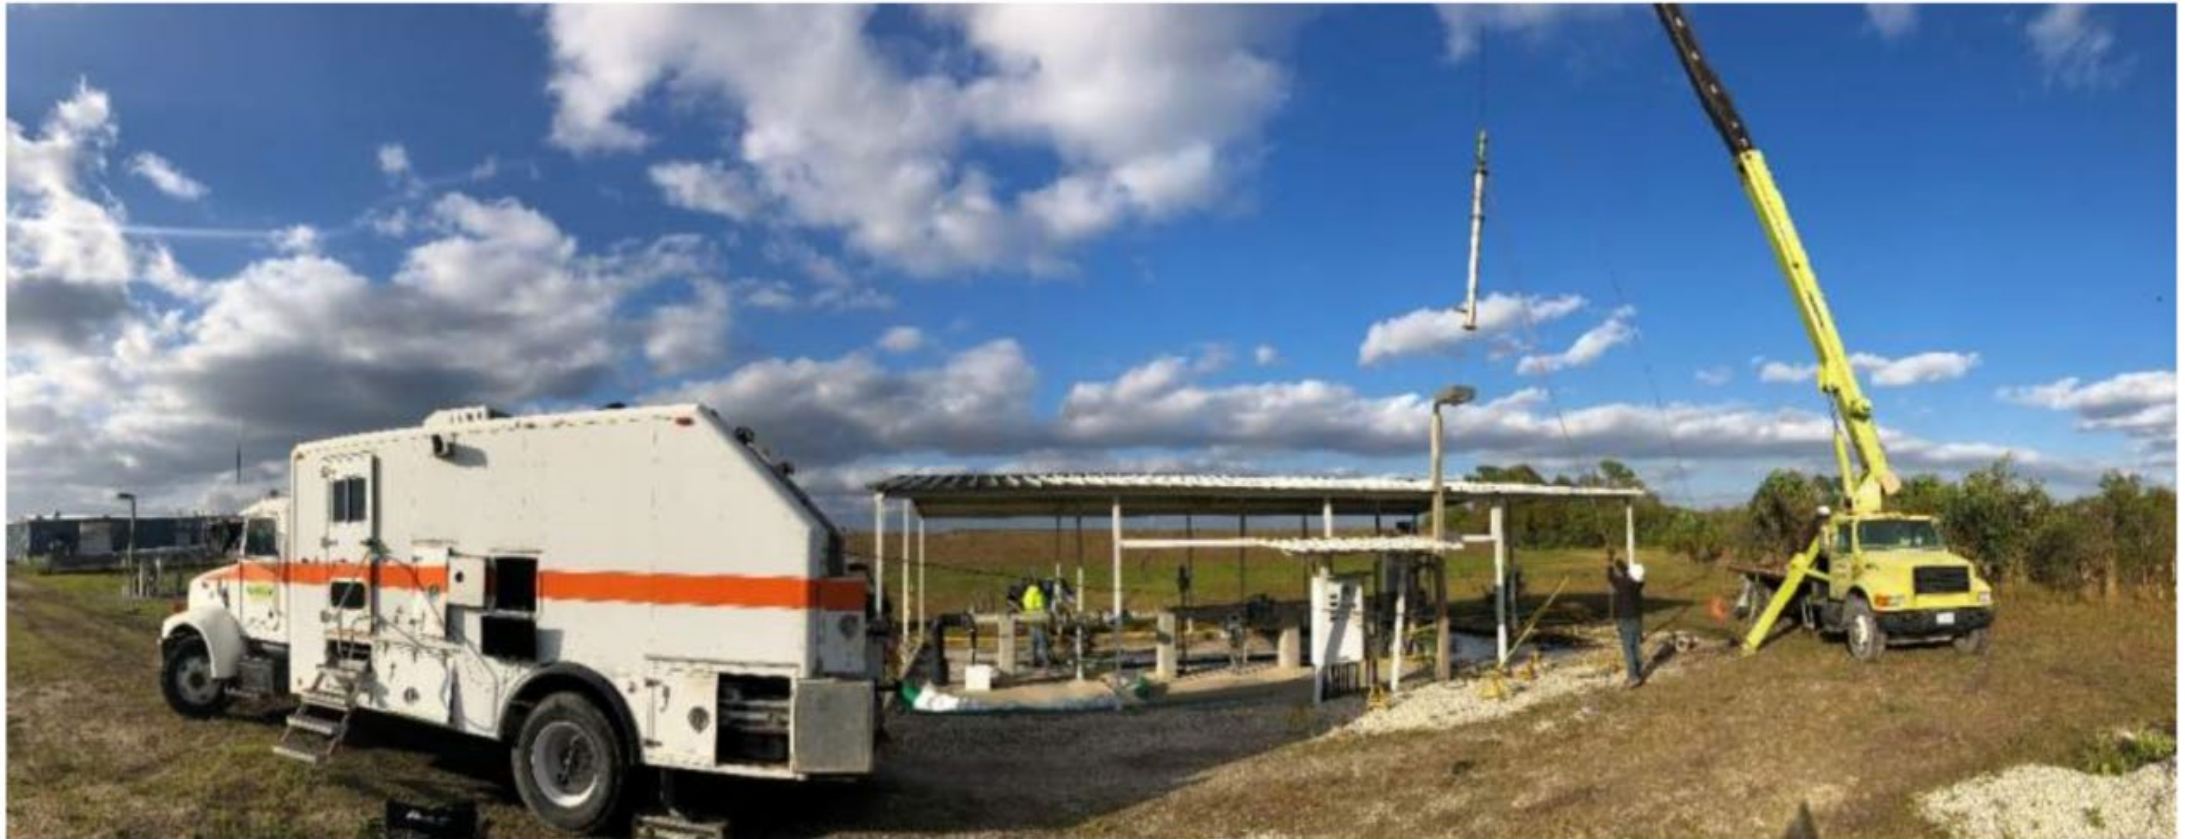
Well Integrity – Video survey

- No evidence of deterioration was visible.
- Findings discussed in a meeting between FDEP, Solid Waste Department and Black & Veatch.

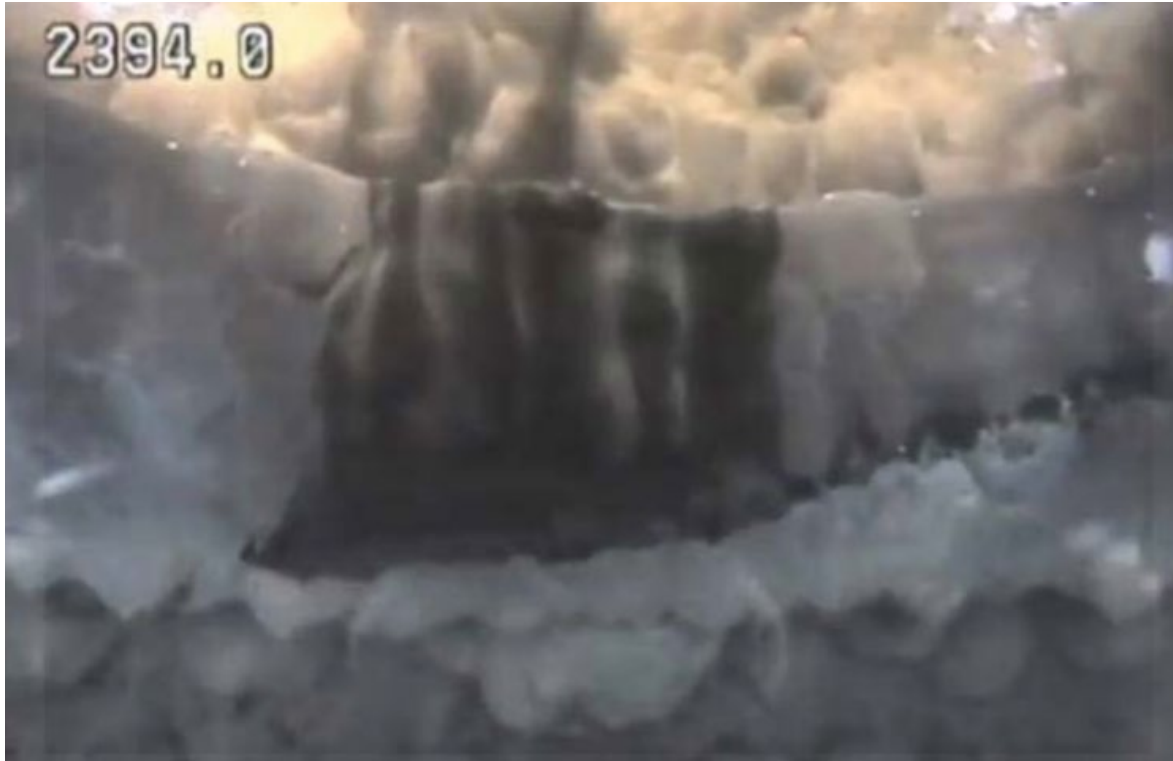
Bottom of the 6.21-inch FRP

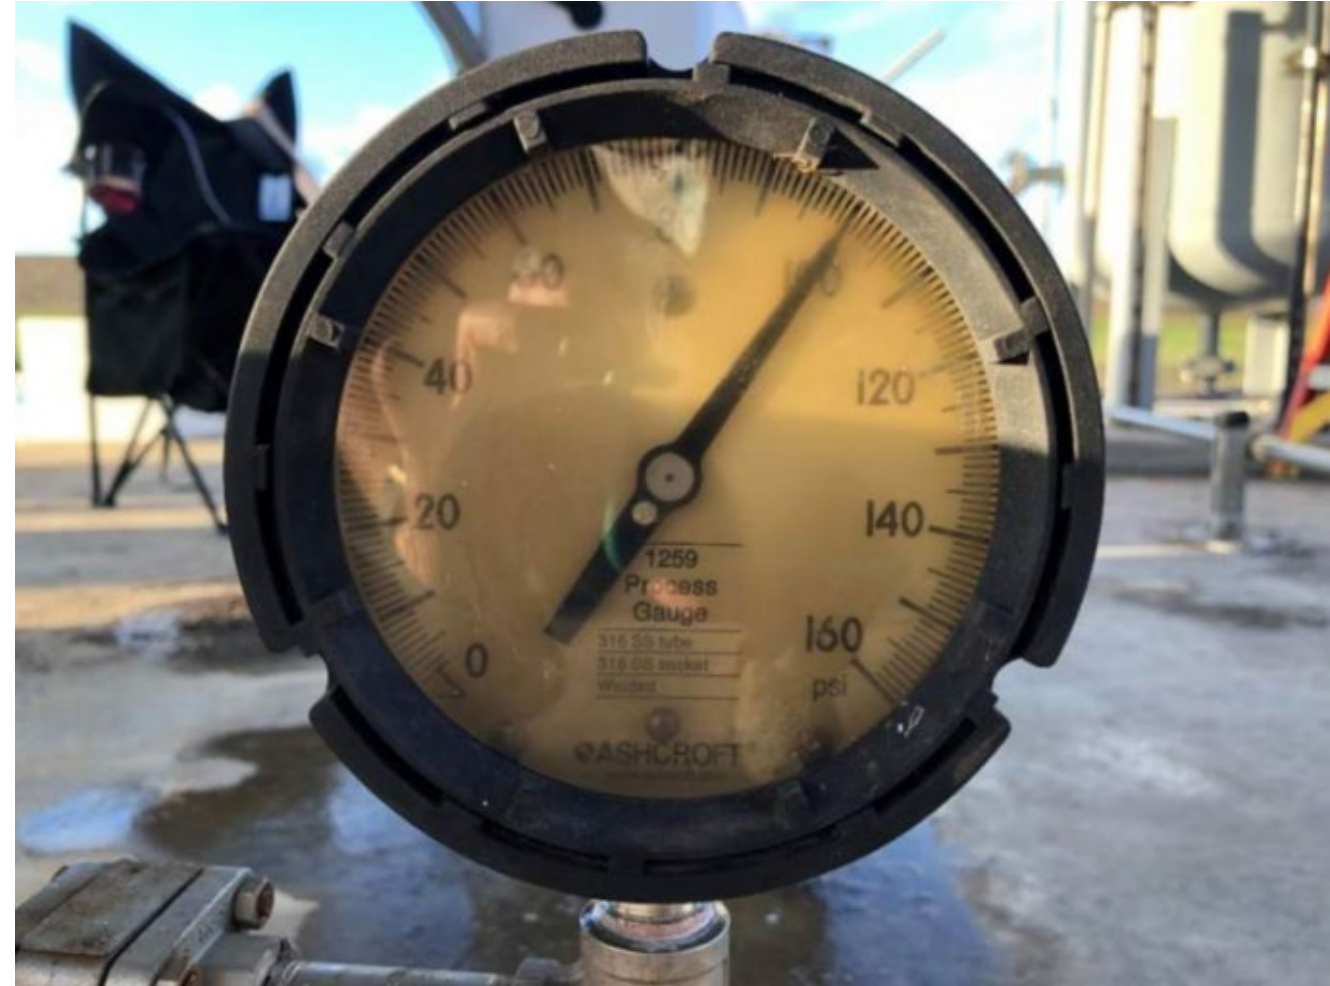
- Annular space filled with water
- Nitrogen gas replaced with water inside the annular tank
- Annulus pressurized to 100 psi
- 24-hour monitoring period
- **Before injection started:**
 - Gradual decrease in pressure
 - 50 psi of nitrogen were used
 - Injection test ultimately aborted.

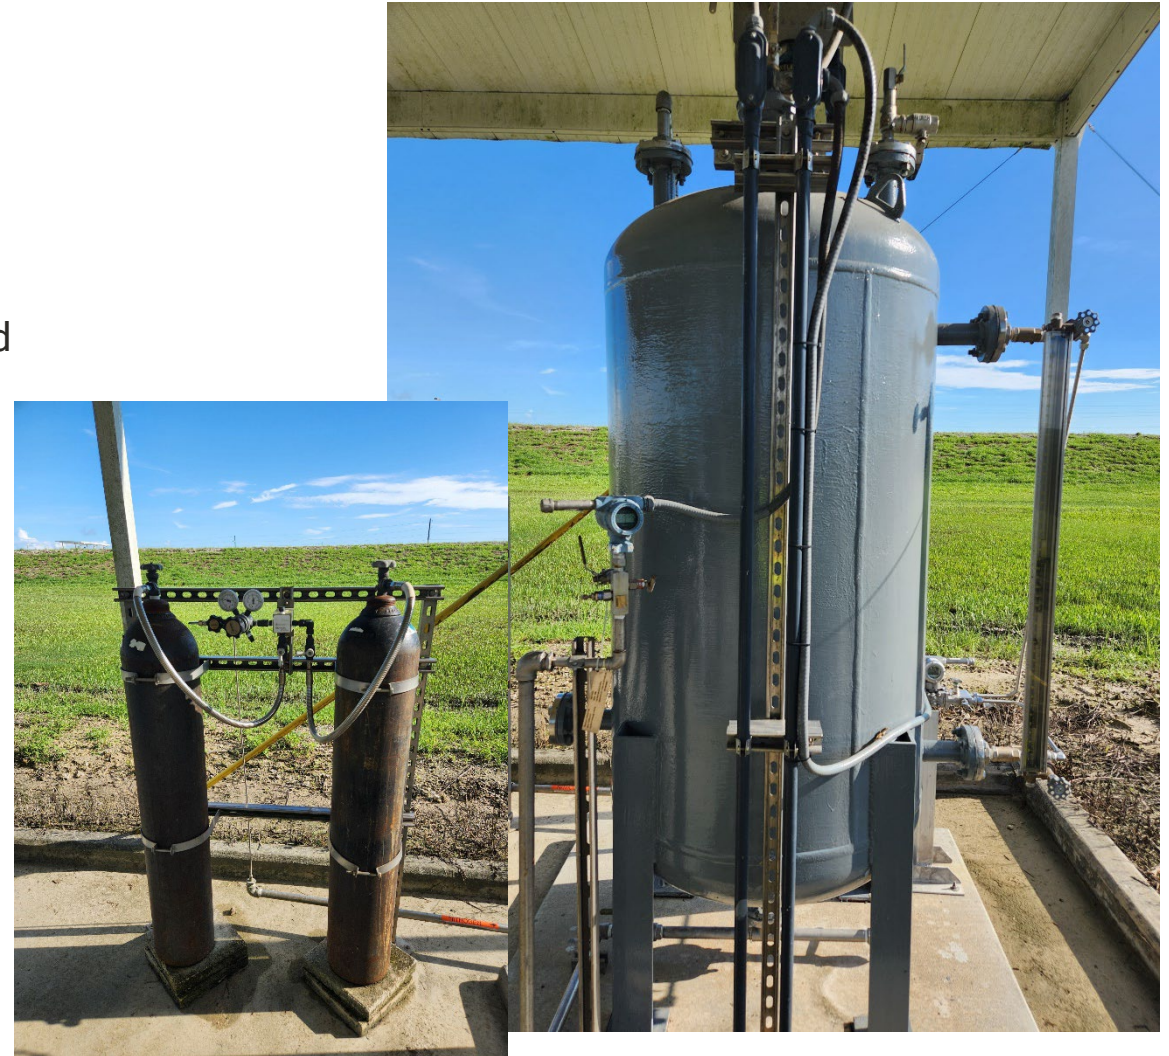
1. Internal FRP Pressure test

- Packer was lowered and installed inside the FRP Tubing.
- FRP tubing was pressurized to 201 psi
 - After 1-hour monitoring period, final pressure was 210 psi
 - 4.5% variation from initial pressure
- **Pressure test was successfully completed** within the 5-percent tolerance established by the FDEP permit and FAC Chapter 62-528.
- FDEP representatives witnessed the test.

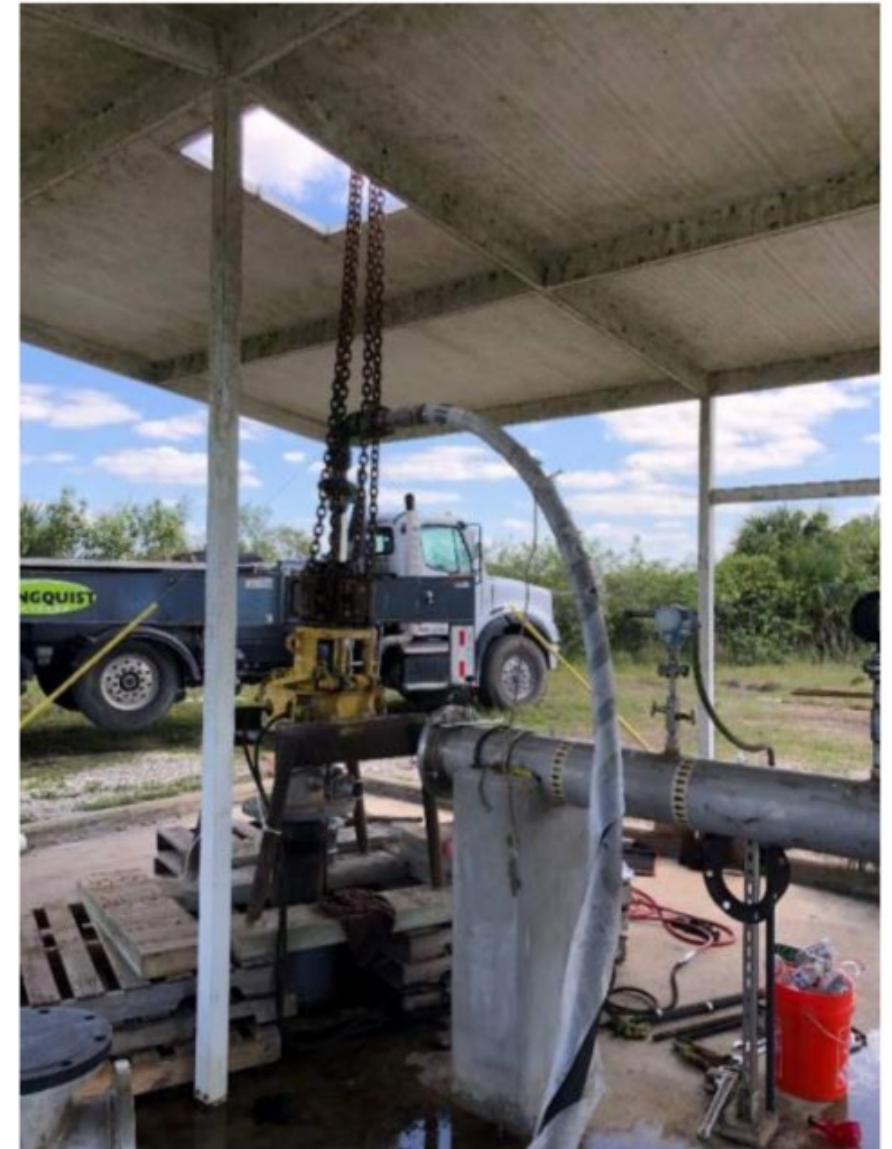
- Elimination process led to the conclusion that **the leak came from the annular space.**
- March 18, 2021
 - Cementing tubing was lowered inside the annular space.
 - Hard tag the positive seal packer element to verify installation depth.
 - A total of 4.3 barrels of neat cement were pumped.

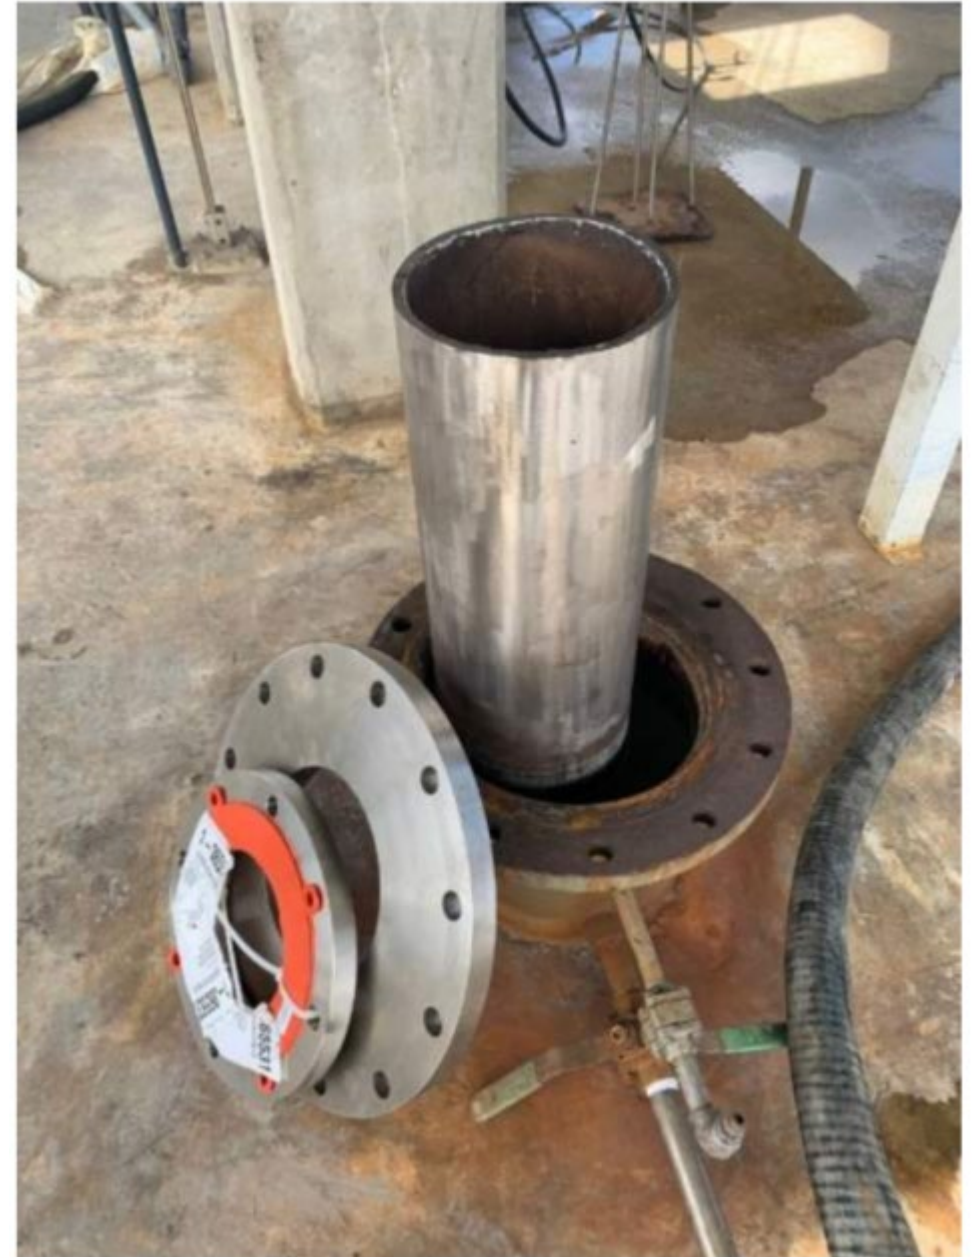
3. Mechanical Integrity Evaluation

- Annular space was filled with 1% Baracor Solution
- MIT was conducted
 - Video survey
 - Annular pressure test
 - RTS and an HRT logs
