# Operational Warning Signs, Root Cause Evaluation & Restoration Strategy for a Large WTE Steam Turbine

*Bill Embree  
Josh Miller, PE*

July 20, 2026

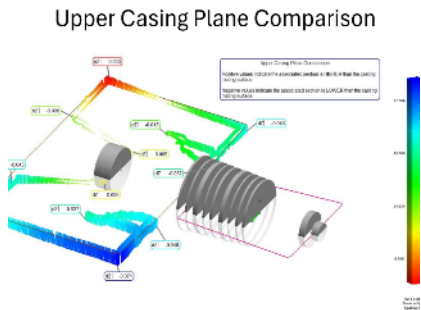
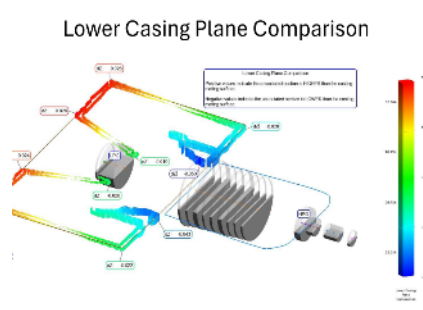
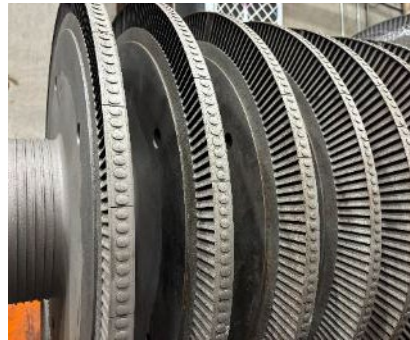
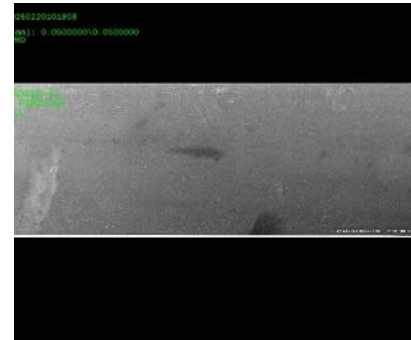
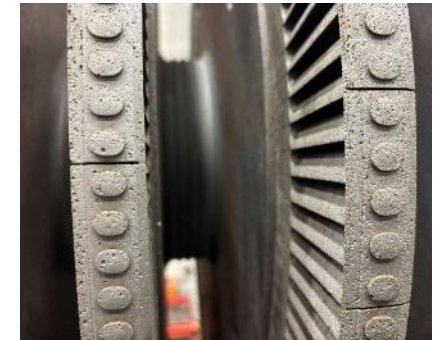
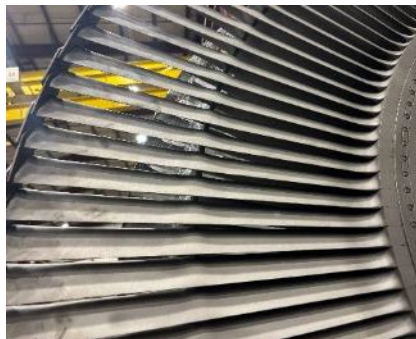
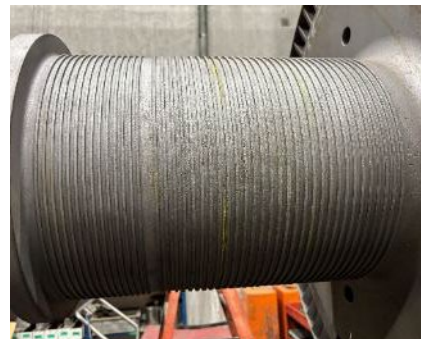
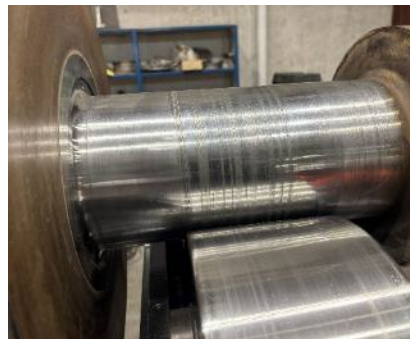
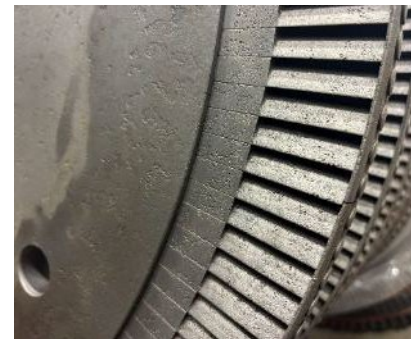
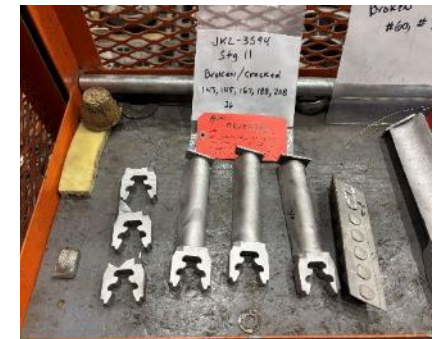
- › Stage 11 blade liberation (2 blades)
- › DOD on stage 12 diaphragms
- › HP gland seal packing failure
- › LP hood crack
- › Pitting/corrosion on stages 2-8
- › Minimal casing erosion

- › Rotor shipped offsite for inspection, repair & low-speed balance
- › Diaphragms 2-6 shipped offsite for inspection/repair; remaining sections addressed at plant
- › LP hood crack evaluated, excavated & re-welded for third time
- › U/L casing plane distortion and concentricity

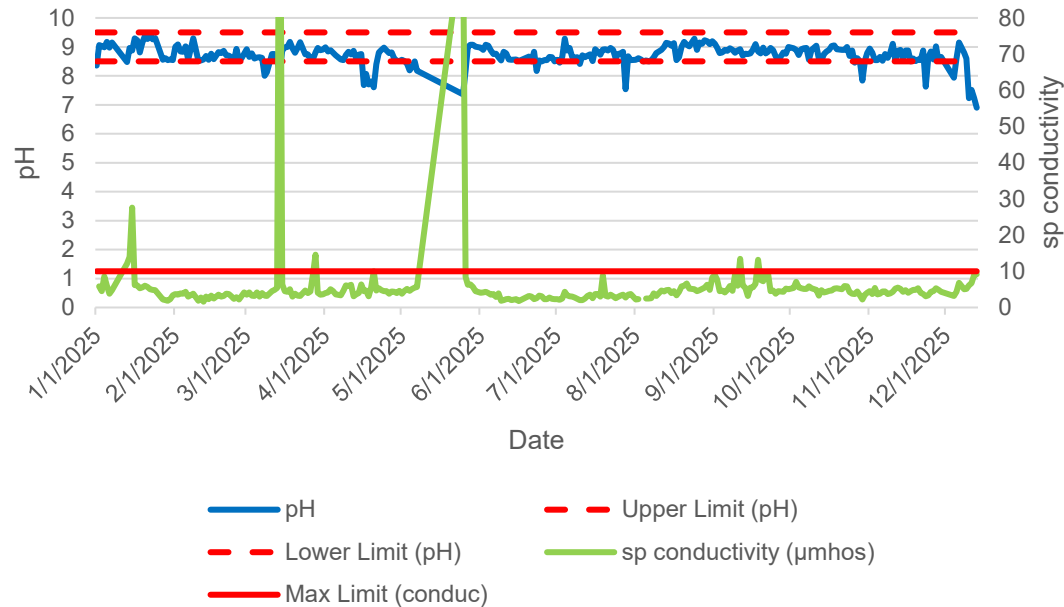
## Feedwater 1: pH & Conductivity vs Time (2025)

- › At least 4 condenser leaks, likely more, pH shows 7
- › May 2025 had serious contamination breach

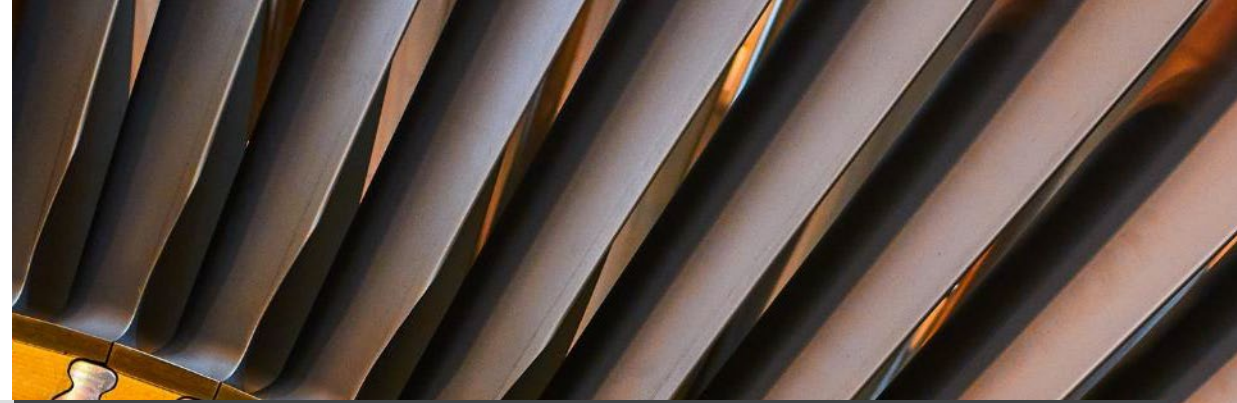
- › Widespread degradation - severe pitting, erosion, rubbing, localized FOD. Most significant damage in Stages 2-8.
- › Admission side erosion on stages 5-8, indicating prolonged exposure to contaminated or erosive steam conditions
- › Stages 3 and 4 exhibited FOD in addition to severe pitting
- › Several stages exhibited opened notches, lack of tenon engagement and rubbing conditions
- › Rotor journals and coupling dimensions were generally within acceptable limits; no cracking indications

Replace Stages 2-8 now, future replacement of Stages 9-10, and correction of several mechanical integrity issues
