Strategic Planning Reclaims Airspace at a Closed Landfill

Manuel Hernandez, P.E., BCEE
Nathan Mayer, P.E.

SCS ENGINEERS

Palm Beach Renewable Energy Park (PBREP)

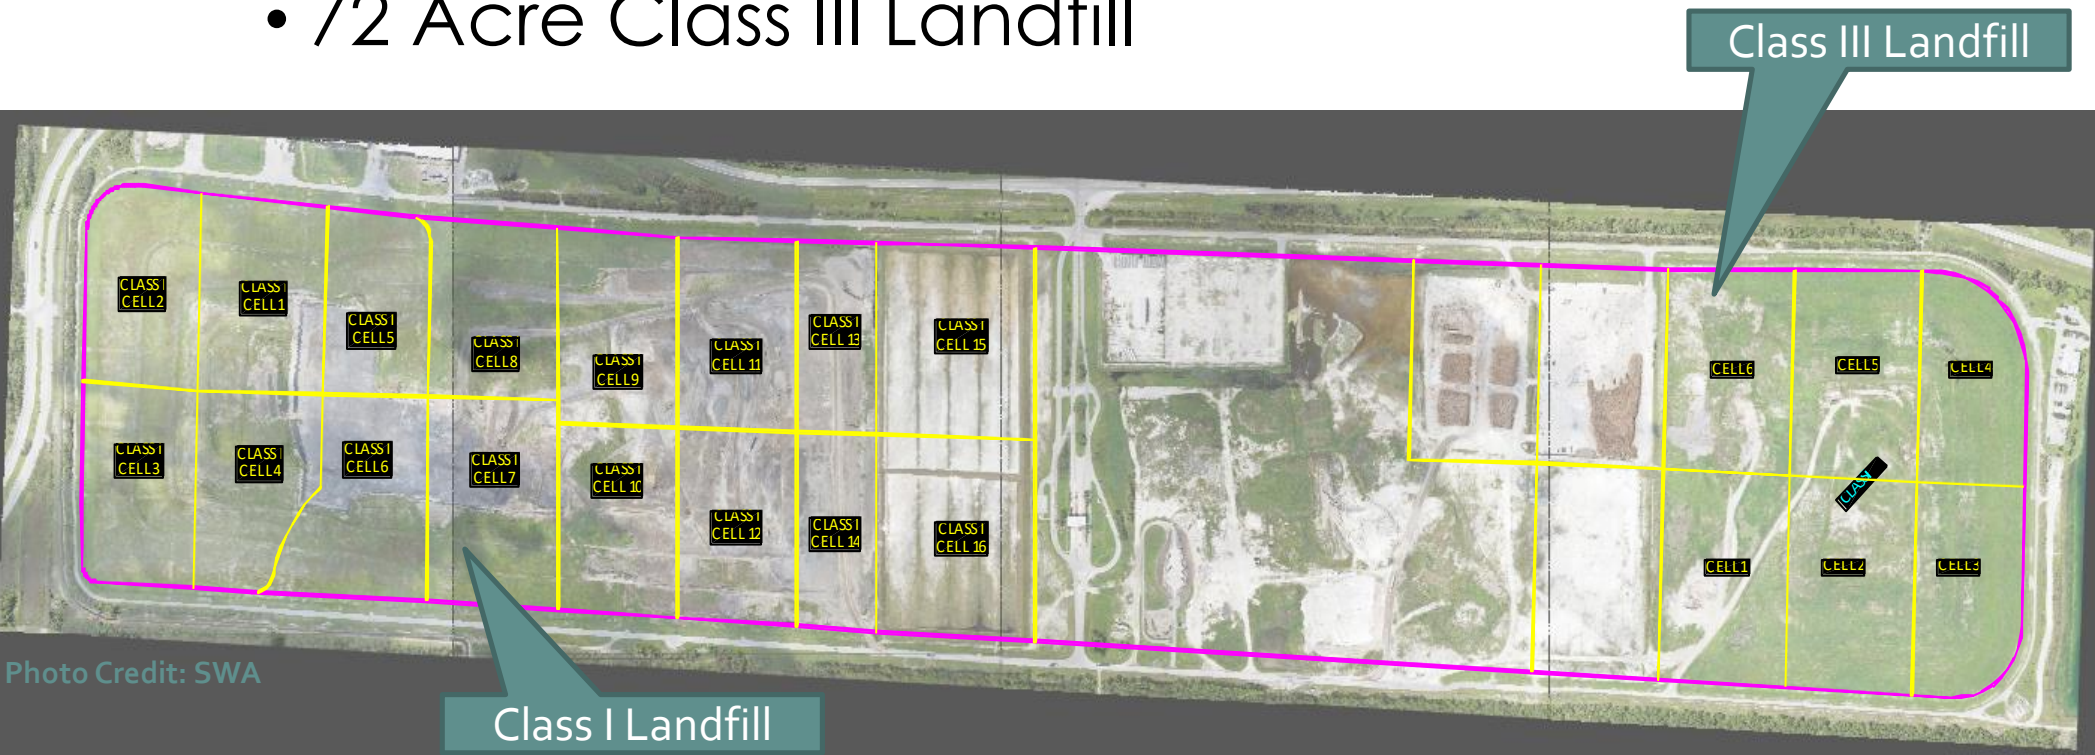
PBREP Landfills

- 262 Acre Class I Landfill
 - Cells 1-6 – Closed 2006
 - Cells 7-10 – Partially Closed 2010
- 72 Acre Class III Landfill

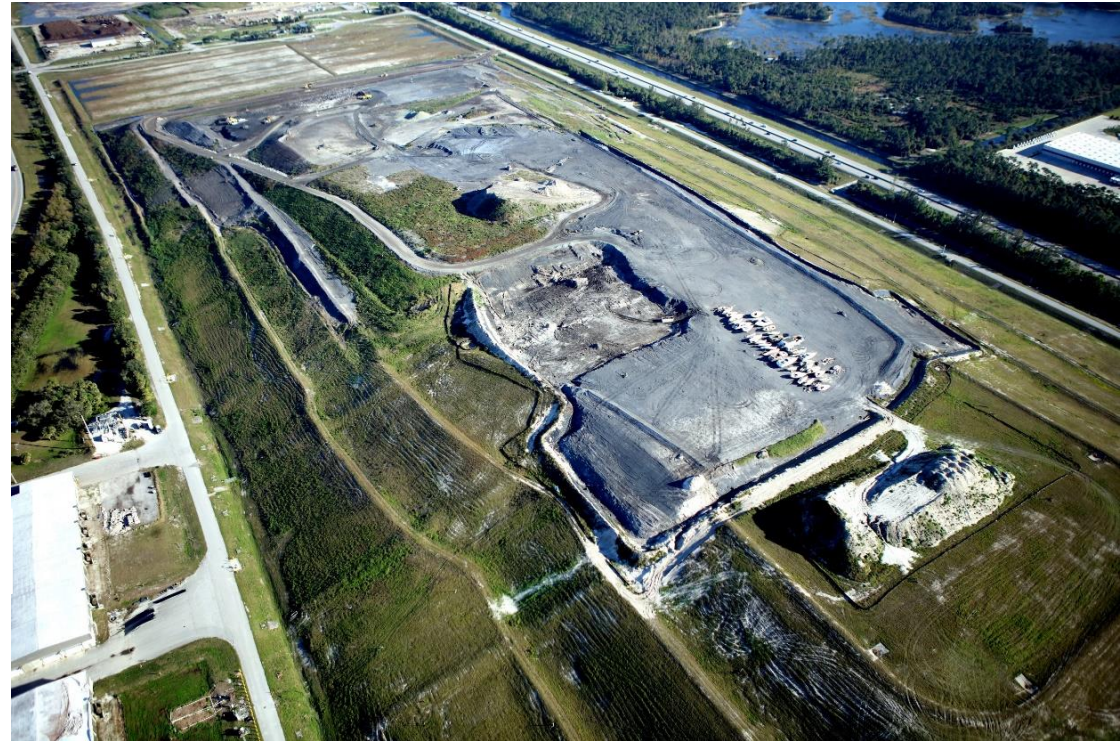
Conditions at Start of Project

- Filling and regrading of Cells 5-6 almost complete
- Filling of Cells 7-10 in progress

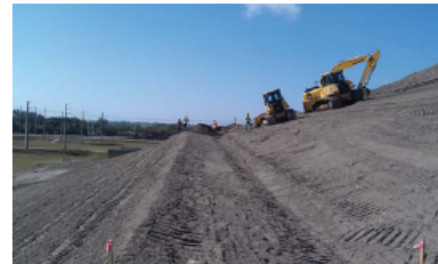
Diagram 1 - Tack-on berm and swale on landfill slope.

Photo 1 - Grading of tack-on berm and swale during construction.

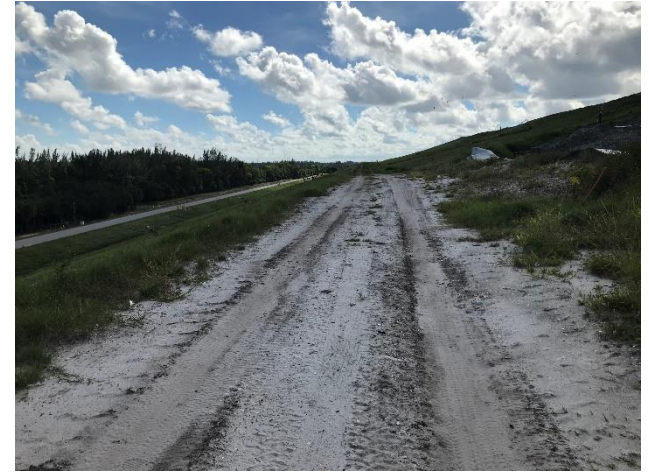
Concerns with Terraces

- Construction and Grading of Terraces
- Settlement
- Stormwater Management
- Leachate Management
- Access Road Crossing

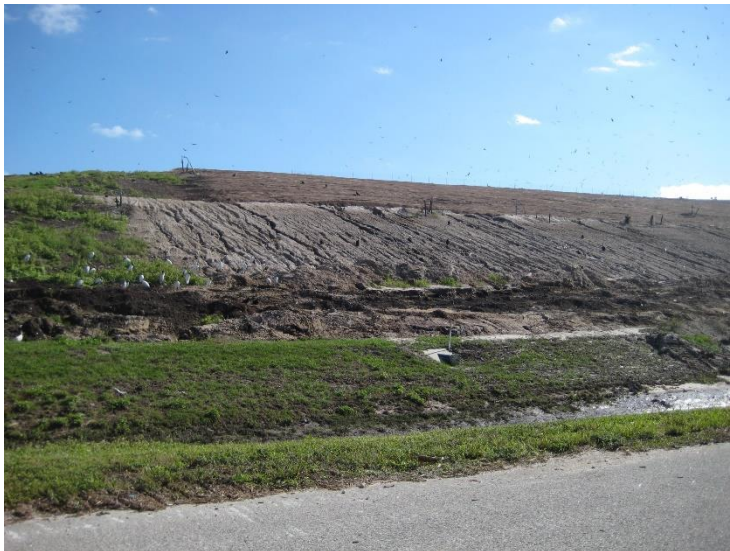
Exiting Terraces

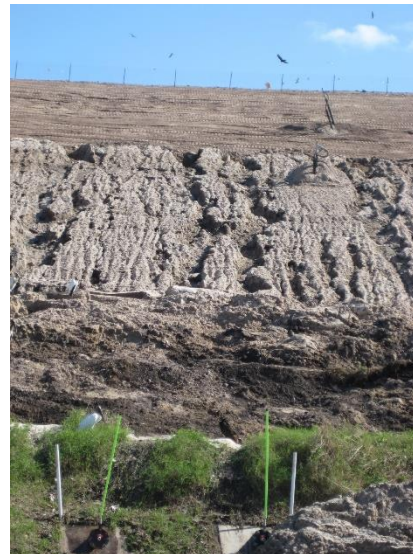
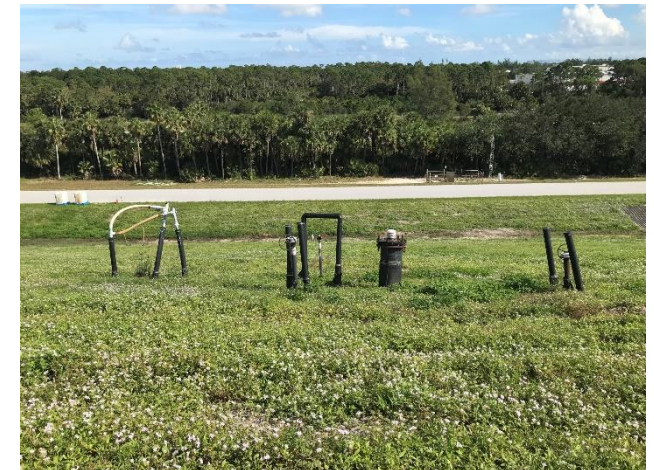
Side slopes prior to Cells 7-10 Partial Closure

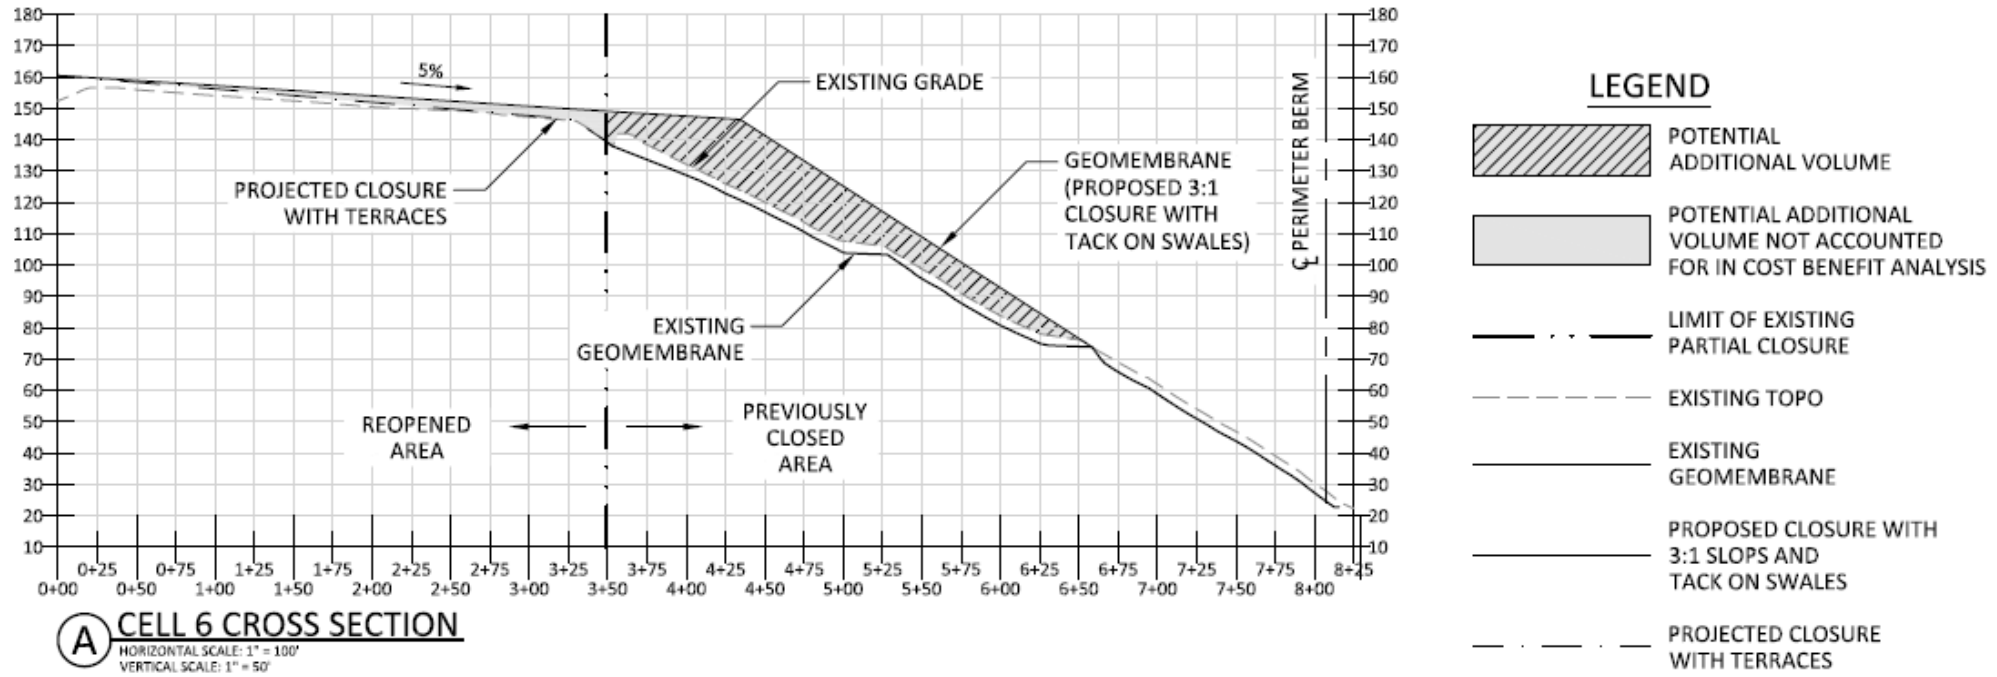
A CELL 6 CROSS SECTION
 HORIZONTAL SCALE: 1" = 100'
 VERTICAL SCALE: 1" = 50'

Cross Section

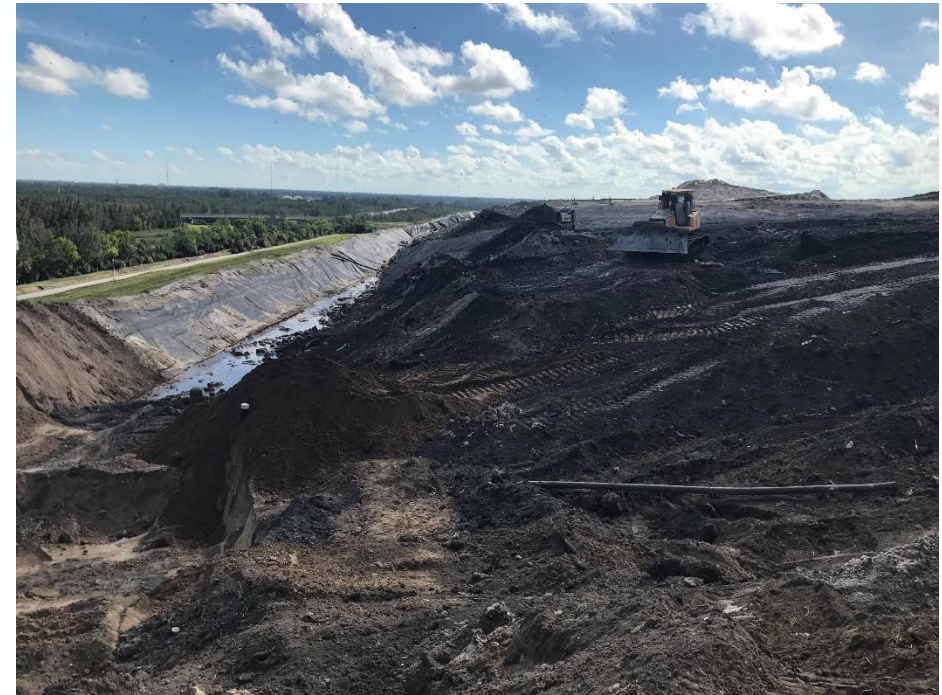
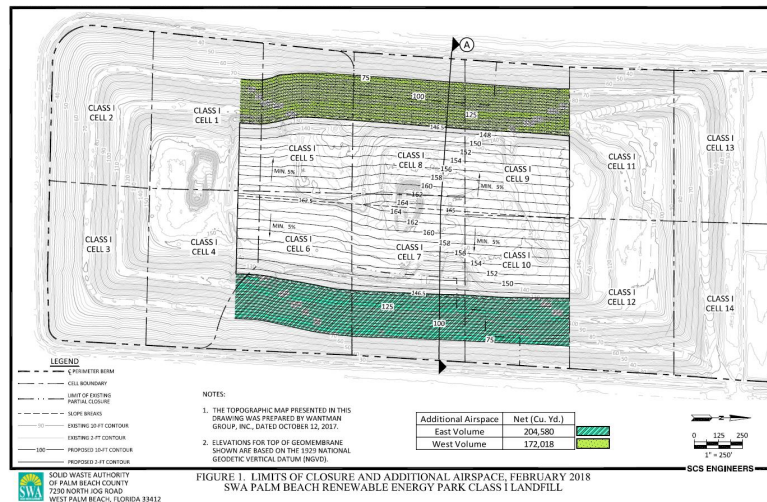
FIGURE 1. LIMITS OF CLOSURE AND ADDITIONAL AIRSPACE, FEBRUARY 2018
 SWA PALM BEACH RENEWABLE ENERGY PARK CLASS I LANDFILL

- Estimated Costs:
 - Removal = \$1,400,000
 - Closure = \$4,100,000

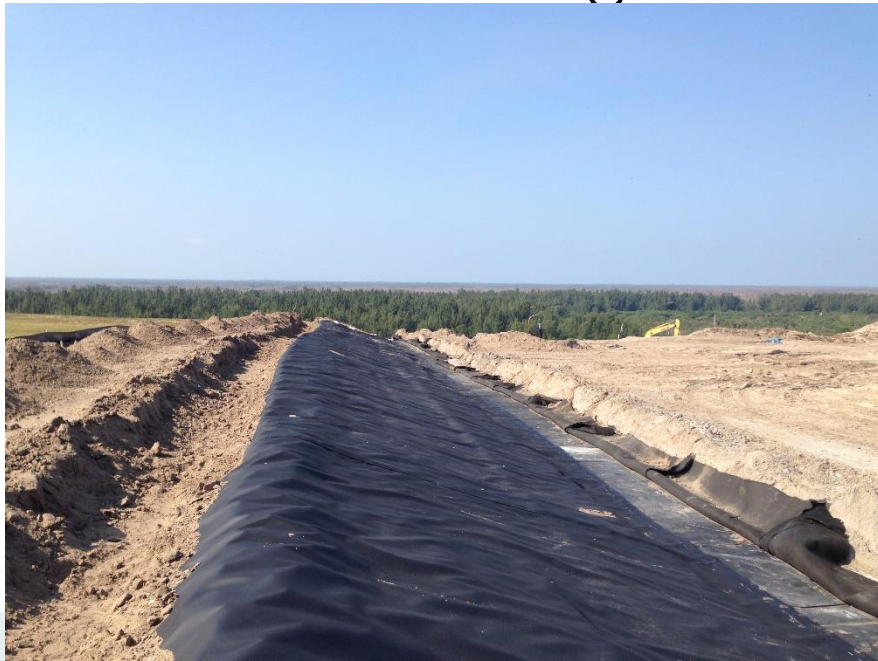
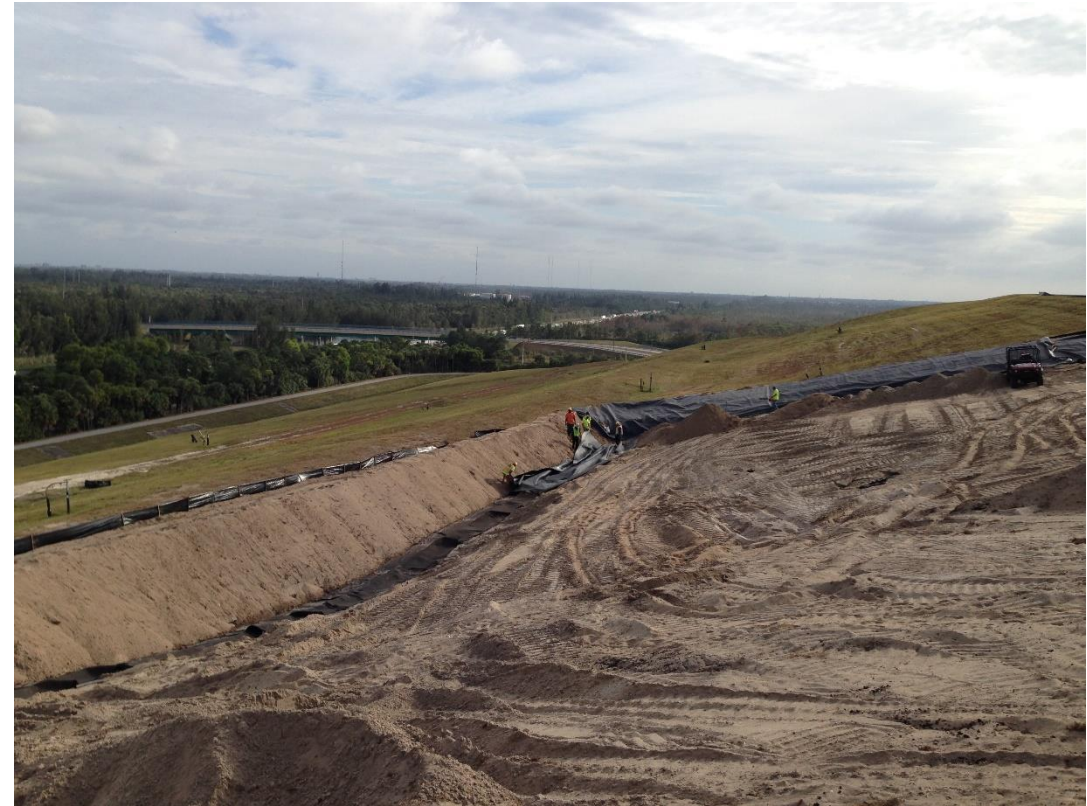
Field Implementation

- Removal of Existing Closure Cap on Cells 5-10
- Stockpiling existing cover soils
- Reuse of liner for leachate management

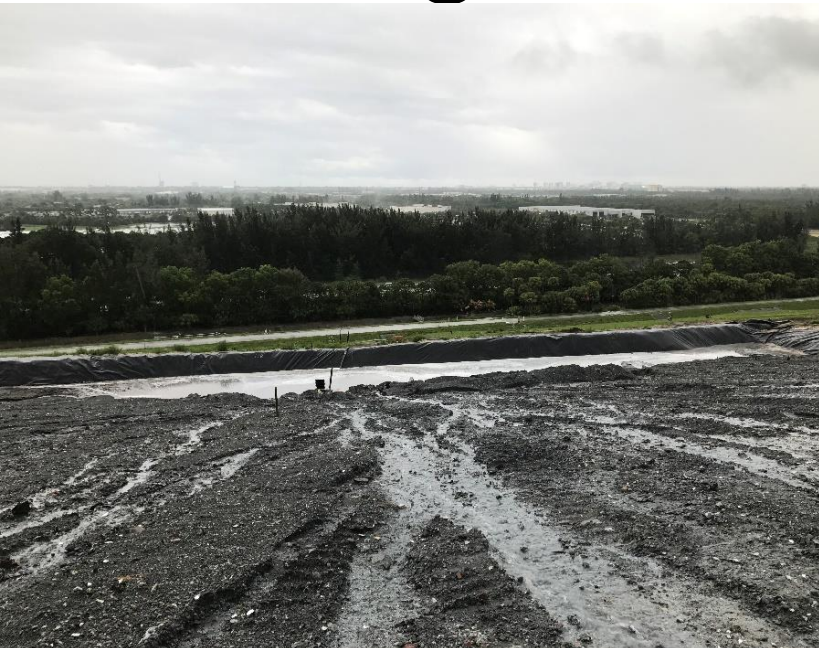
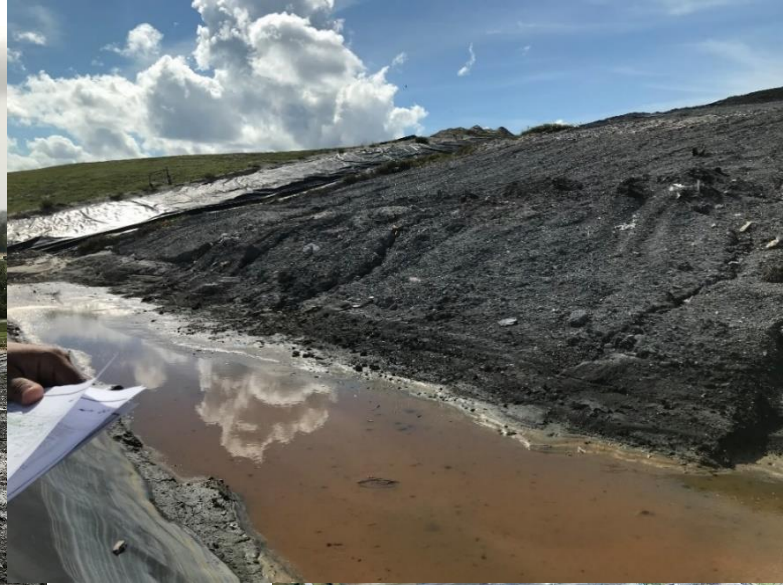
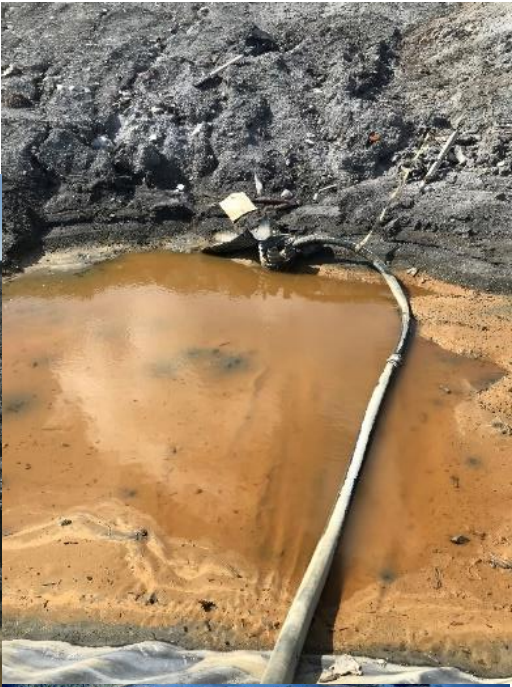
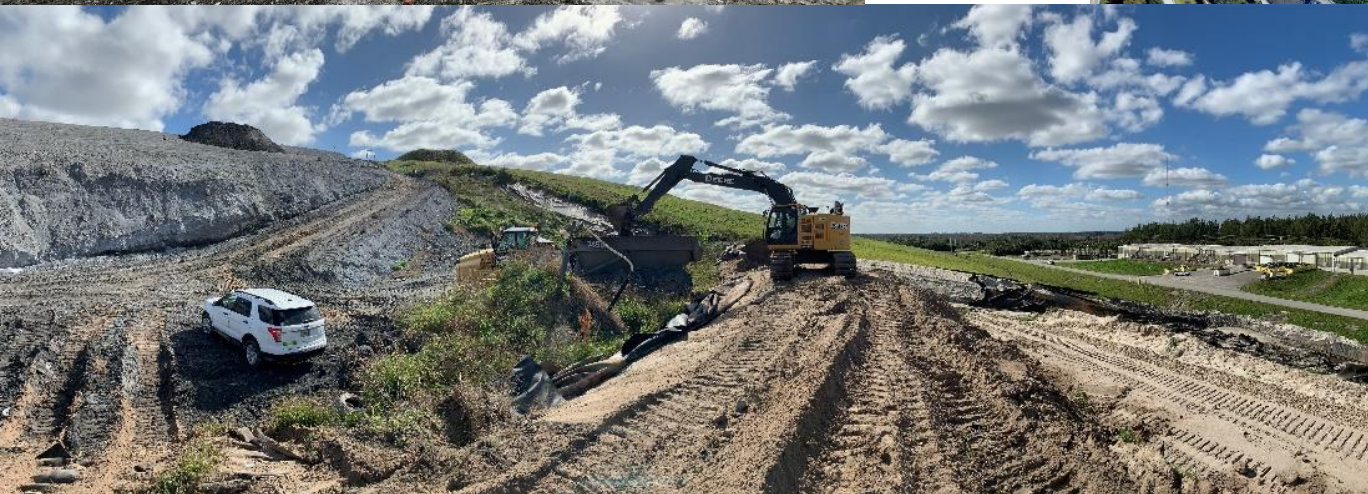
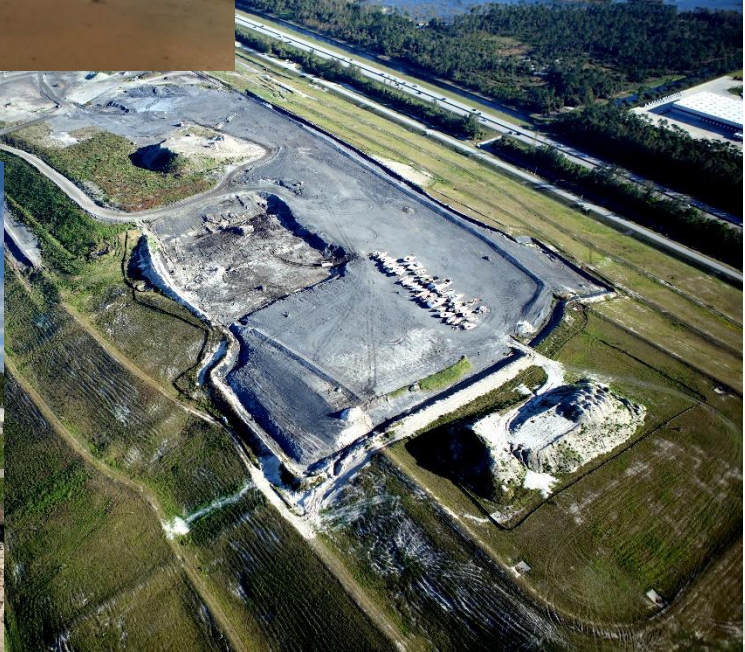
Leachate and Stormwater Management
